Norwich Western Link

Environmental Statement

Chapter 11: Bats

Appendix 3b: Structure Roosting Bats

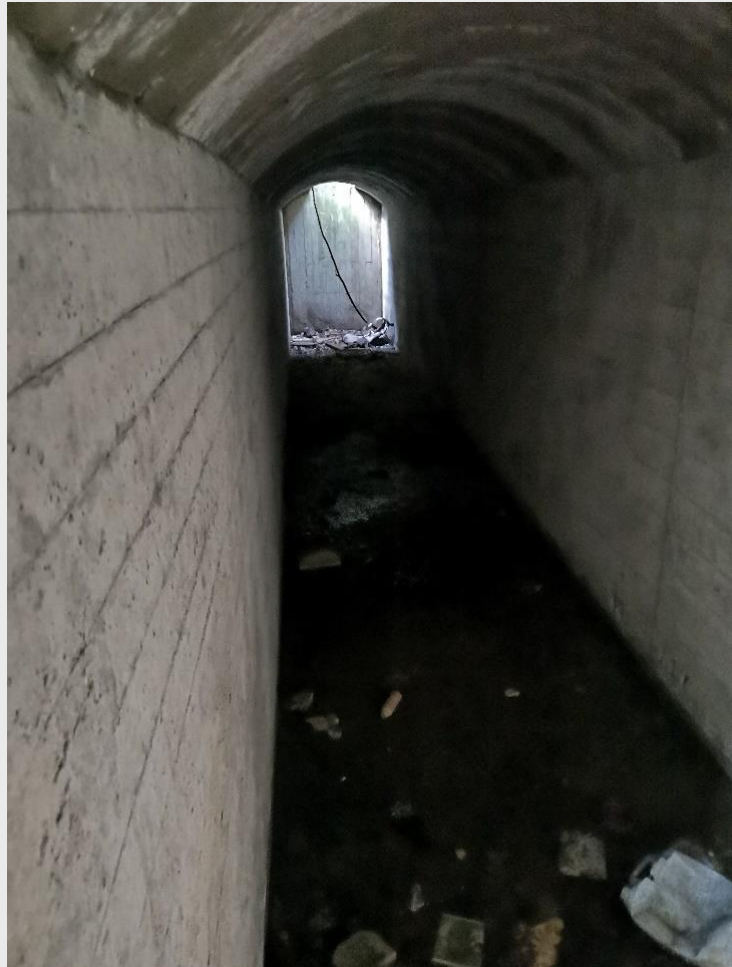
- 9B1 – An image showing tunnel with a curved ceiling of an above ground concrete structure approximately 1.5m high and 2m long. Significant light exposure, and draughty.
- 9B2 – An image of an underground bunker entrance, with steps covered in leaves down into a space approximately 2.5m high by 2m wide, and 10m long. Entrance is covered in moss.

Structure ref	Structure Description	Hibernation Survey Visit 1 Results	Hibernation Survey Visit 2 Results	Hibernation Roost Status	Structure Photograph
9B1	An above ground concrete structure approximately 1.5m high and 2m long. Significant light exposure, and draughty.	<p>25 February 2021</p> <p>No hibernating bats or evidence of hibernating bats recorded.</p>	<p>26 March 2021</p> <p>No hibernating bats or evidence of hibernating bats recorded.</p>	Hibernating bats considered to be likely absent.

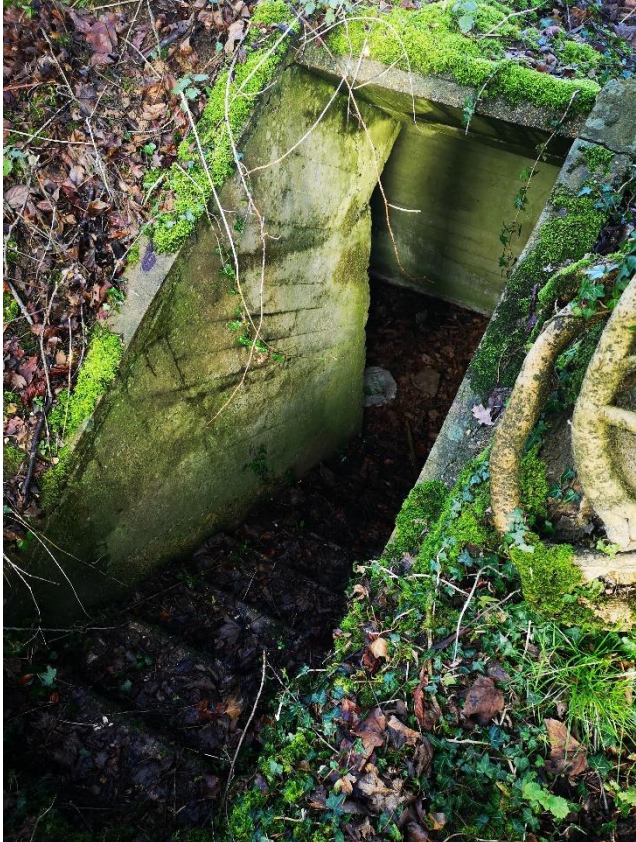
Structure ref	Structure Description	Hibernation Survey Visit 1 Results	Hibernation Survey Visit 2 Results	Hibernation Roost Status	Structure Photograph
9B2	Underground bunker with steps leading into a space approximately 2.5m high by 2m wide, and 10m long. Walls and ceiling comprised of concrete panels which were tightly sealed with no gaps between them.	<p>25 February 2021</p> <p>Small pile of insect wings located in the centre of the bunker.</p> <p>No hibernating bats or conclusive evidence of hibernating bats recorded.</p>	<p>26 March 2021</p> <p>No hibernating bats or evidence of hibernating bats recorded.</p>	Hibernating bats considered to be likely absent.

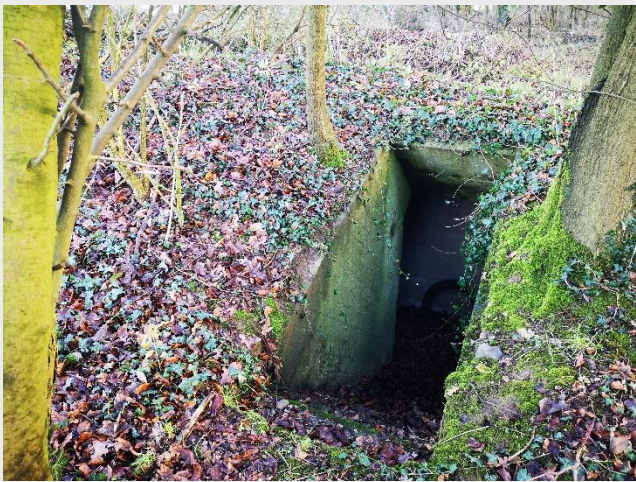
- 9B3 - An image of an underground bunker entrance, with steps covered in leaves down into a space approximately 2.5m high by 2m wide, and 10m long. Entrance is surrounded by Ivy.

9B3	Underground bunker with steps leading into a space approximately 2.5m high by 2m wide, and 10m long. Walls and ceiling comprised of concrete panels which were tightly sealed with no gaps between them.	<p>25 February 2021</p> <p>No hibernating bats or evidence of hibernating bats recorded.</p>	<p>26 March 2021</p> <p>No hibernating bats or evidence of hibernating bats recorded.</p>	Hibernating bats considered to be likely absent.

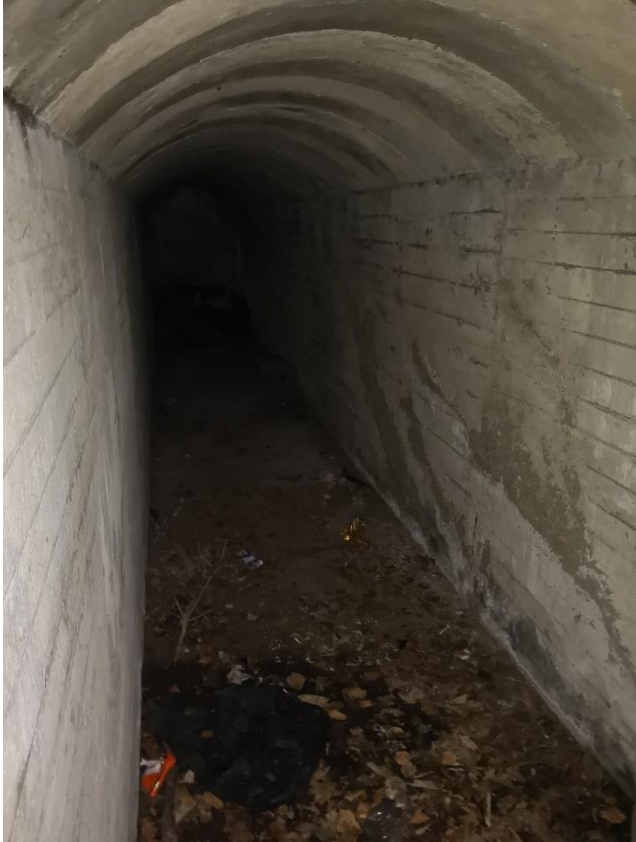
- 9B4 - An image showing a tunnel of an underground concrete bunker, with blocked doorway and an arched ceiling. Leaves on tunnel floor.
- 9B5 – Image showing a narrow skylight entrance which leads vertically down into the bunker.

Structure ref	Structure Description	Hibernation Survey Visit 1 Results	Hibernation Survey Visit 2 Results	Hibernation Roost Status	Structure Photograph
9B4	Underground concrete bunker, with blocked doorway. An open 'skylight' access/egress point is clear and accessible.	25 February 2021 Not possible to inspect – filled with earth and bricks at entrance.	26 March 2021 Inspected – tar spilled on floor. One dead bat recorded in tar, and two additional dead bats found on walls. Old droppings at the far end of the tunnel.	Historic confirmed hibernation roost

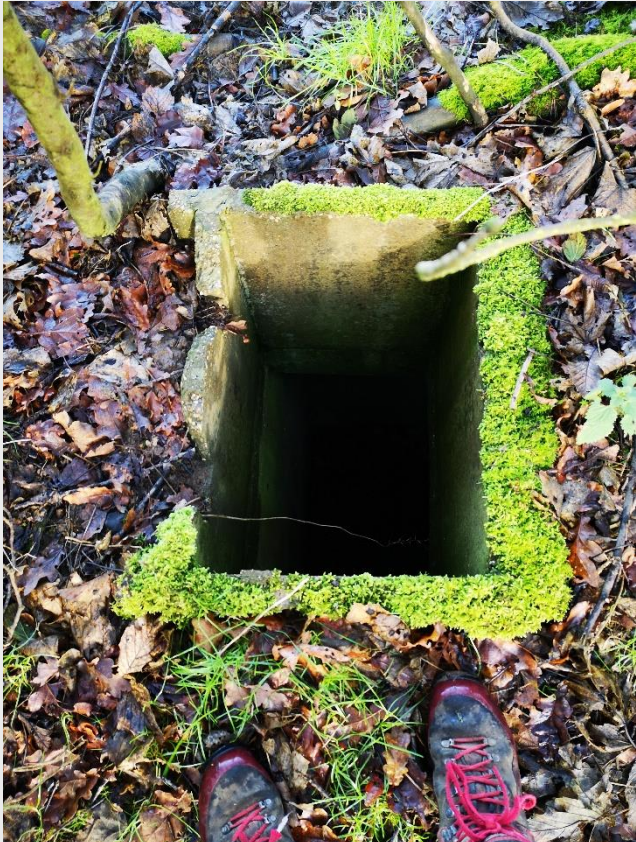
9B5	Underground bunker with steps leading into a concrete tunnel, which could not be accessed due to debris blocking the entrance. A narrow skylight entrance is also present which leads vertically down into the bunker.	25 February 2021 Not inspected, structure entrance filled in with soil and debris.	26 March 2021 Not inspected, structure entrance filled in with soil and debris.	Hibernating bats considered to be likely absent.

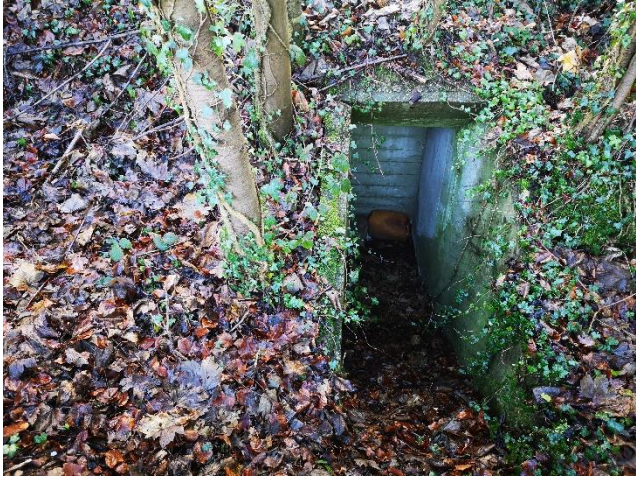
- 9B6 - An image of an underground bunker entrance, with steps covered in leaves down into a space approximately 2.5m high by 2m wide, and 10m long. Entrance is surrounded by Ivy.

Structure ref	Structure Description	Hibernation Survey Visit 1 Results	Hibernation Survey Visit 2 Results	Hibernation Roost Status	Structure Photograph
9B6	Underground bunker with steps leading into a space approximately 2.5m high by 2m wide, and 10m long. Walls and ceiling comprised of concrete panels with gaps between these where the mortar has degraded.	<p>25 February 2021</p> <p>Multiple crevices recorded between the concrete panels where bats could roost.</p> <p>Three hibernating bats identified between gaps in roof:</p> <ul style="list-style-type: none"> • Single brown long-eared bat; • Single <i>Myotis</i> sp.; and • Single unidentified bat. 	<p>26 March 2021</p> <p>Single <i>Myotis</i> sp. bat identified, considered to likely be Daubenton's bat <i>Myotis daubentonii</i>.</p>	Confirmed hibernation roost.

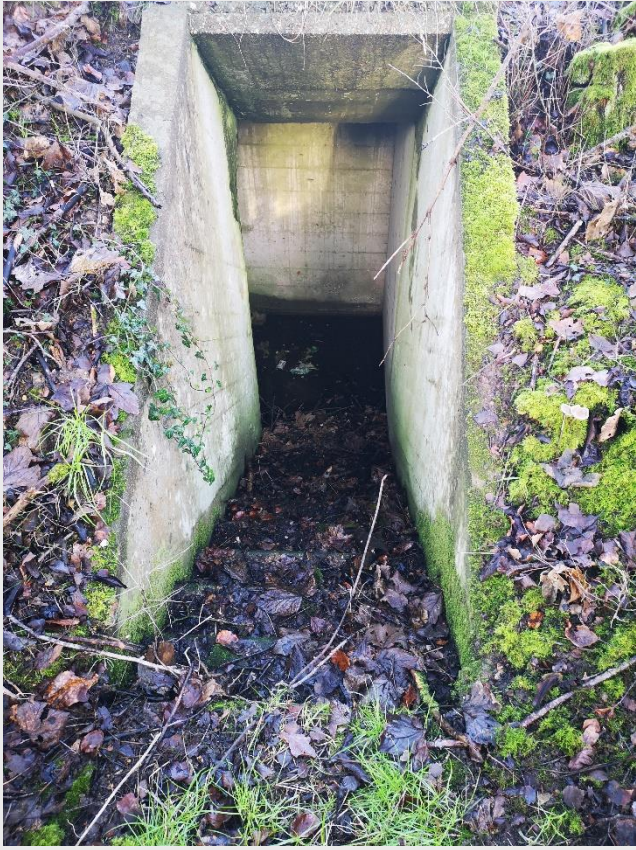
- 9B7 - An image of an underground bunker entrance, with steps covered in leaves down into a space approximately 2.5m high by 2m wide, and 10m long. Entrance is surrounded by moss.

9B7	Underground bunker with steps leading into a space approximately 2.5m high by 2m wide, and 10m long. Walls and ceiling comprised of concrete panels which were tightly sealed with no gaps between them.	<p>25 February 2021</p> <p>No hibernating bats or evidence of hibernating bats recorded.</p>	<p>26 March 2021</p> <p>Structure partially flooded. No hibernating bats or evidence of hibernating bats recorded.</p>	Hibernating bats considered to be likely absent.

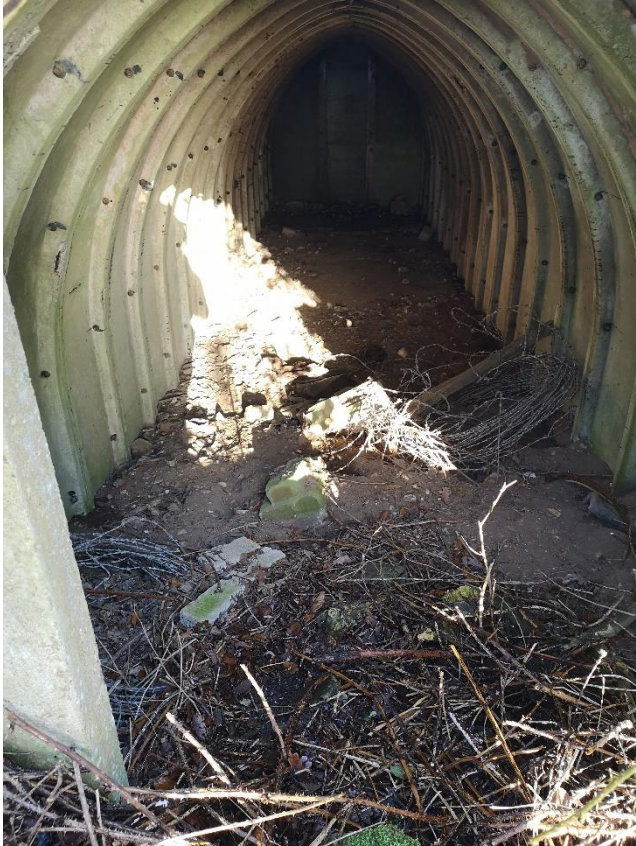
- 10A1 – Image of inside an above ground structure, showing an arched roof and internally comprised of concrete panels which are sealed at all the joints. Floor is covered in debris such as twigs and a rung of barbed wire.

Structure ref	Structure Description	Hibernation Survey Visit 1 Results	Hibernation Survey Visit 2 Results	Hibernation Roost Status	Structure Photograph
10A1	Above ground structure. Internally comprised of concrete panels which are sealed at all the joints.	25 February 2021 No hibernating bats or evidence of hibernating bats recorded.	26 March 2021 No hibernating bats or evidence of hibernating bats recorded.	Hibernating bats considered to be likely absent.

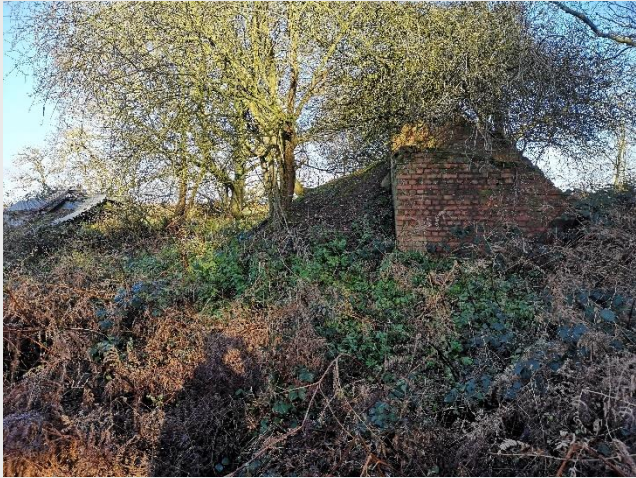
- 10A2 – Image of an above ground structure surrounded by bracken and a tree, but with earth piled on top so that it appears underground.
- 10A3 – Image of above ground structure entrance, leading right into the bunker.

10A2	Above ground structure but with earth piled on top so that it appears underground. Internally comprised of concrete panels with gaps in the joints and behind the concrete doorframe.	25 February 2021 No hibernating bats or evidence of hibernating bats recorded.	26 March 2021 No hibernating bats or evidence of hibernating bats recorded.	Hibernating bats considered to be likely absent.

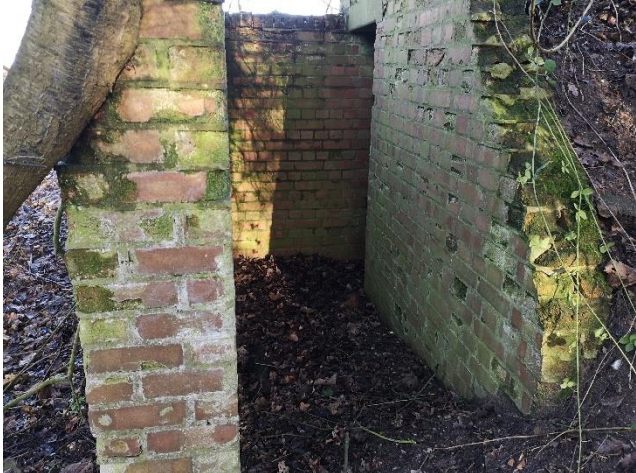
Structure ref	Structure Description	Hibernation Survey Visit 1 Results	Hibernation Survey Visit 2 Results	Hibernation Roost Status	Structure Photograph
10A3	Above ground structure but with earth piled on top so that it appears underground. Internally comprised of concrete panels with gaps in the joints and behind the concrete doorframe.	25 February 2021 Single brown long-eared bat observed within the structure of the doorframe.	26 March 2021 Single brown long-eared bat observed within the door frame structure. Droppings with size and shape indicative of brown long-eared bat round under ridge at the far end of bunker.	Confirmed hibernation roost.

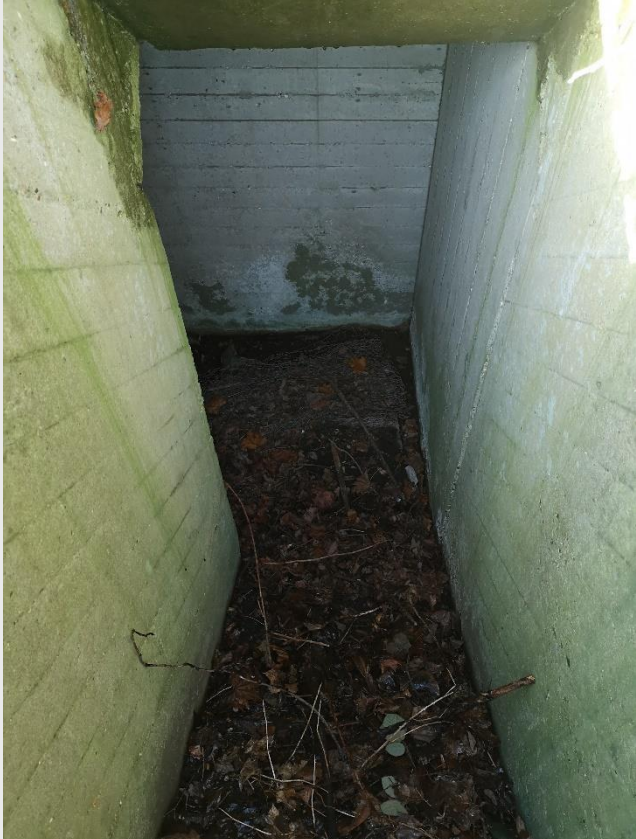
- 11A1 - An image of an underground bunker entrance, into a space approximately 2.5m high by 2m wide, and 10m long. Leaves cover the floor.
- 11A2 - An image showing tunnel with a curved ceiling of an above ground concrete structure approximately 1.5m high and 2m long. Significant light exposure, and draughty.

11A1	Underground bunker with steps leading into a space approximately 2.5m high by 2m wide, and 10m long. Walls and ceiling comprised of concrete panels with gaps between these where the mortar has degraded.	25 February 2021 No hibernating bats or evidence of hibernating bats recorded.	26 March 2021 Droppings present under mortar gaps. Size and appearance indicative of brown long-eared bat.	Confirmed hibernation roost.

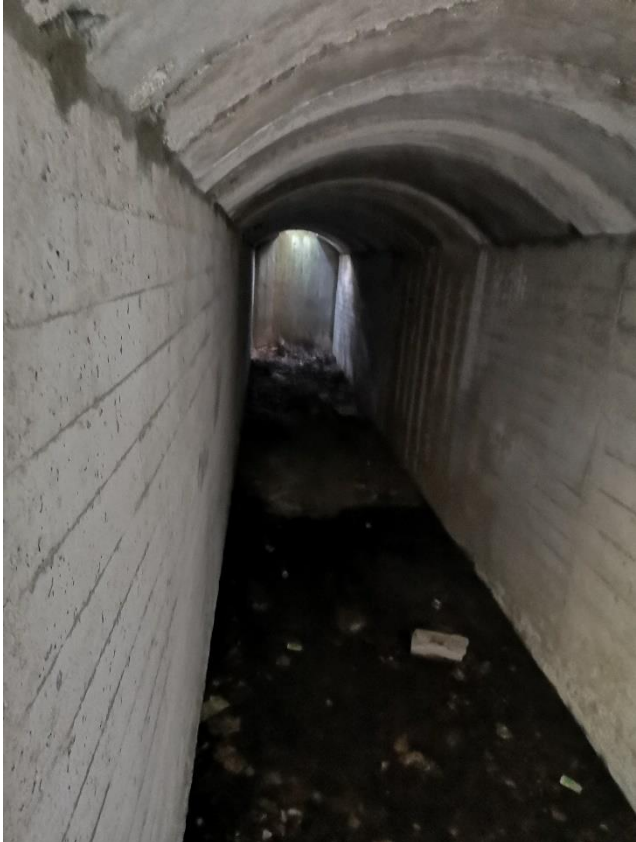
Structure ref	Structure Description	Hibernation Survey Visit 1 Results	Hibernation Survey Visit 2 Results	Hibernation Roost Status	Structure Photograph
11A2	Underground bunker with steps leading into a space approximately 2.5m high by 2m wide, and 10m long. Walls and ceiling comprised of concrete panels with gaps between these where the mortar has degraded.	25 February 2021 No hibernating bats or evidence of hibernating bats recorded	26 March 2021 Droppings present under mortar gaps. Size and appearance indicative of brown long-eared bat.	Confirmed hibernation roost

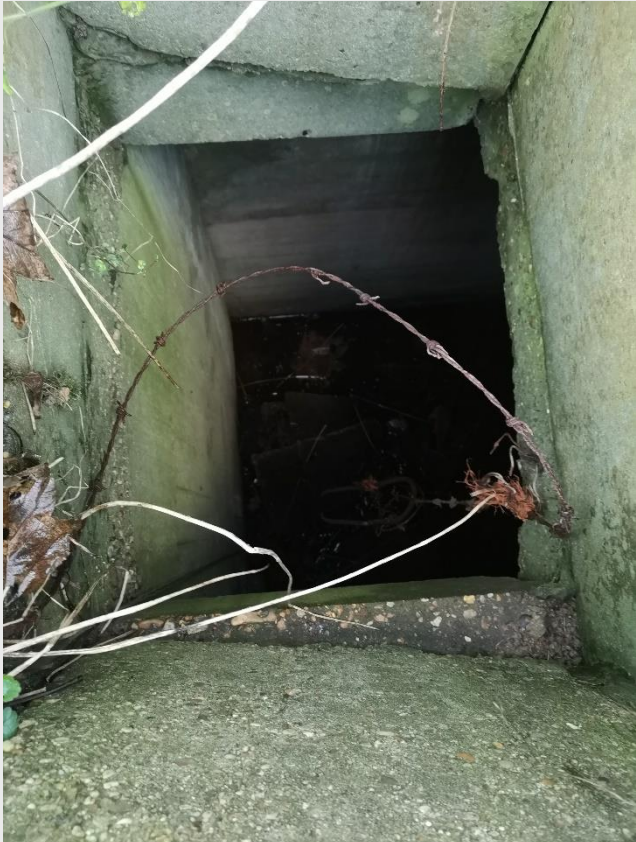
- 11A3 - Image showing a narrow skylight entrance which leads vertically down into the bunker.
- Rutterford 1 – Image showing the entrance to a large agricultural shed with concrete foundations. Upper half of walls are constructed of corrugated metal panels. Tractor in entrance.

11A3	Underground bunker with steps leading into a space approximately 2.5m high by 2m wide, and 10m long. Walls and ceiling comprised of concrete panels with gaps between these where the mortar has degraded.	25 February 2021 Two hibernating bats recorded within concrete blocks in the roof: <ul style="list-style-type: none"> • Single brown long-eared bat; and • Single Daubenton's bat 	26 March 2021 Structure partially flooded with 2-3 inches of ground water. Three brown long-eared bats recorded in mortar gaps.	Confirmed hibernation roost.

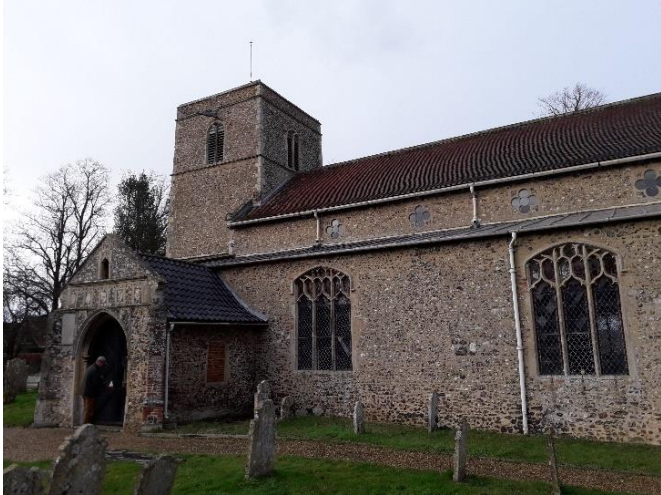
- All Saints Church – Image showing a local church of stone and concrete construction, with a pitched tiled roof (and a smaller pitched roof over the entrance way).

Structure ref	Structure Description	Hibernation Survey Visit 1 Results	Hibernation Survey Visit 2 Results	Hibernation Roost Status	Structure Photograph
All Saints Church, Lenwade	Local church of stone and concrete construction, with a pitched tiled roof (and a smaller pitched roof over the entrance way). Internally, the structure features a wooden-panelled ceiling.	13 January 2021 External and internal inspection completed, but no access to loft or roof cavity. No hibernating bats or evidence of hibernating bats recorded.	24 February 2021 External and internal inspection completed, but no access to loft or roof cavity. Single <i>Pipistrellus</i> sp. hibernating behind door lock in the east of the building. Cluster of droppings recorded around a window on the western aspect, with droppings sporadically scattered throughout the main space. Urine staining observed on pews and stone burial caps.	Confirmed hibernation roost.

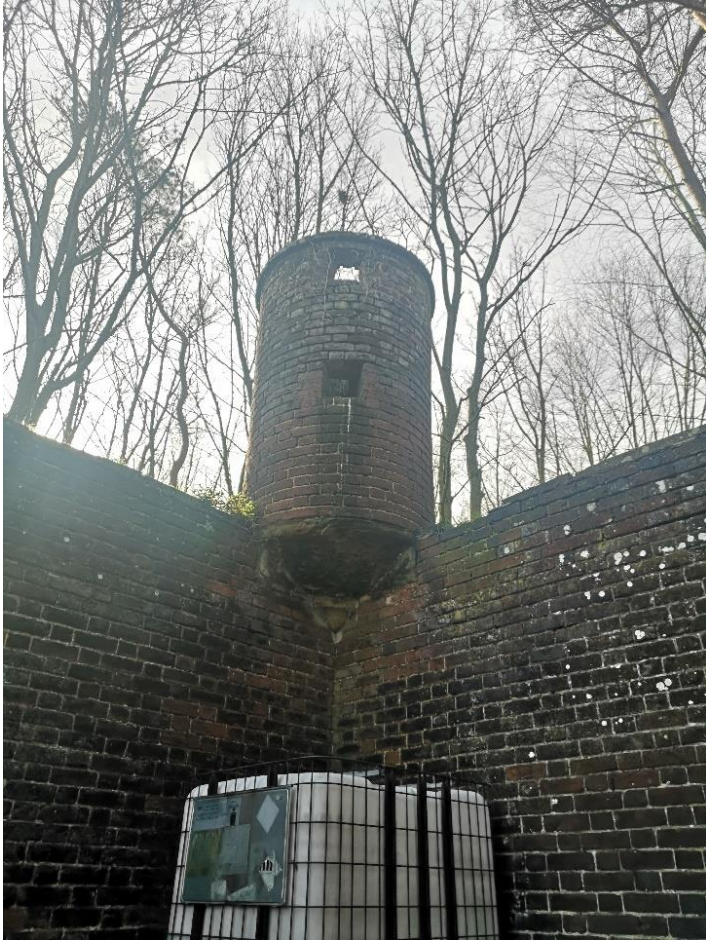
Morton Farm 1	Modern agricultural barn structure, which did not meet the scope for further surveys.	21 January 2021 External inspection only. No hibernating bats or evidence of hibernating bats recorded. Building considered unsuitable to support an important hibernation roost.	N/A	Unconfirmed, but unlikely to support important hibernation roost due to nature of structure.	N/A
Morton Farm 2	Large agricultural barn with wooden roof structure and corrugated asbestos roof. No external walls on the N, E or S sides. W side is bounded by a tall (6-8m) brick wall. Some missing mortar at the top of the wall provides potential roost features but too high to inspect. A brick turret/guard post is present in the SW corner of the wall structure. No access inside the barn on first survey visit due to farm machinery movements during survey within the barn.	21 January 2021 External inspection only. No hibernating bats or evidence of hibernating bats recorded.	24 February 2021 External and internal inspection. No hibernating bats or evidence of hibernating bats recorded.	Hibernating bats considered to be likely absent.

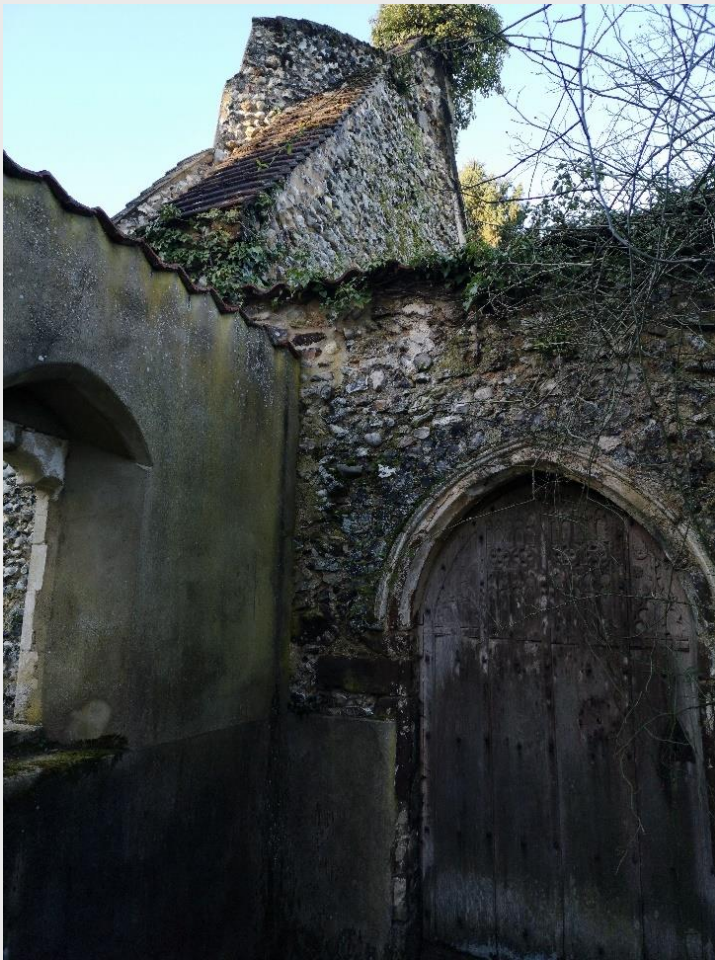
Structure ref	Structure Description	Hibernation Survey Visit 1 Results	Hibernation Survey Visit 2 Results	Hibernation Roost Status	Structure Photograph
45A5	Stone constructed green house with more modern glass, possibly Victorian or older. Lower structure contains gaps and crevices where old pipework would have been to heat the green house. Limited suitability for roosting or hibernation. Structure did not meet the scope for further surveys.	21 January 2021 External inspection only. No hibernating bats or evidence of hibernating bats recorded.	N/A	Unconfirmed, but unlikely to support important hibernation roost due to nature of structure.	N/A
45A6	<p>Small chapel constructed from stone with Norfolk pantile style roof. The eastern end of the chapel has been refurbished and has a glass wall separating it from the western end which has not be refurbished. The pantile roof provides multiple entry points for bats into the roof structure and there are multiple gaps where the soffit boards meet the stonework. The western end of the building has no roof and the round tower also has no roof. Missing mortar provides some potential for hibernating bats but features not accessible from the ground or ladders. Exterior features were attempted to endoscope but most were too tight for the endoscope head or opened into voids too large to inspected with an endoscope. A brick water well is present to the south which is open at the top but access is partly obscured by ivy. The well was filled with water at the time of the visit and the structure has limited suitability for hibernation.</p> <p>Building interior has been refurbished and walls and ceilings are finished with white render. There is a void between the pantile roof and internal ceiling that cannot be accessed for survey. A thorough inspection of was carried out using torches by three</p>	21 January 2021 Internal and external inspection. No hibernating bats or evidence of hibernating bats recorded.	24 February 2021 Internal and external inspection. No hibernating bats or evidence of hibernating bats recorded.	Hibernating bats considered to be likely absent.

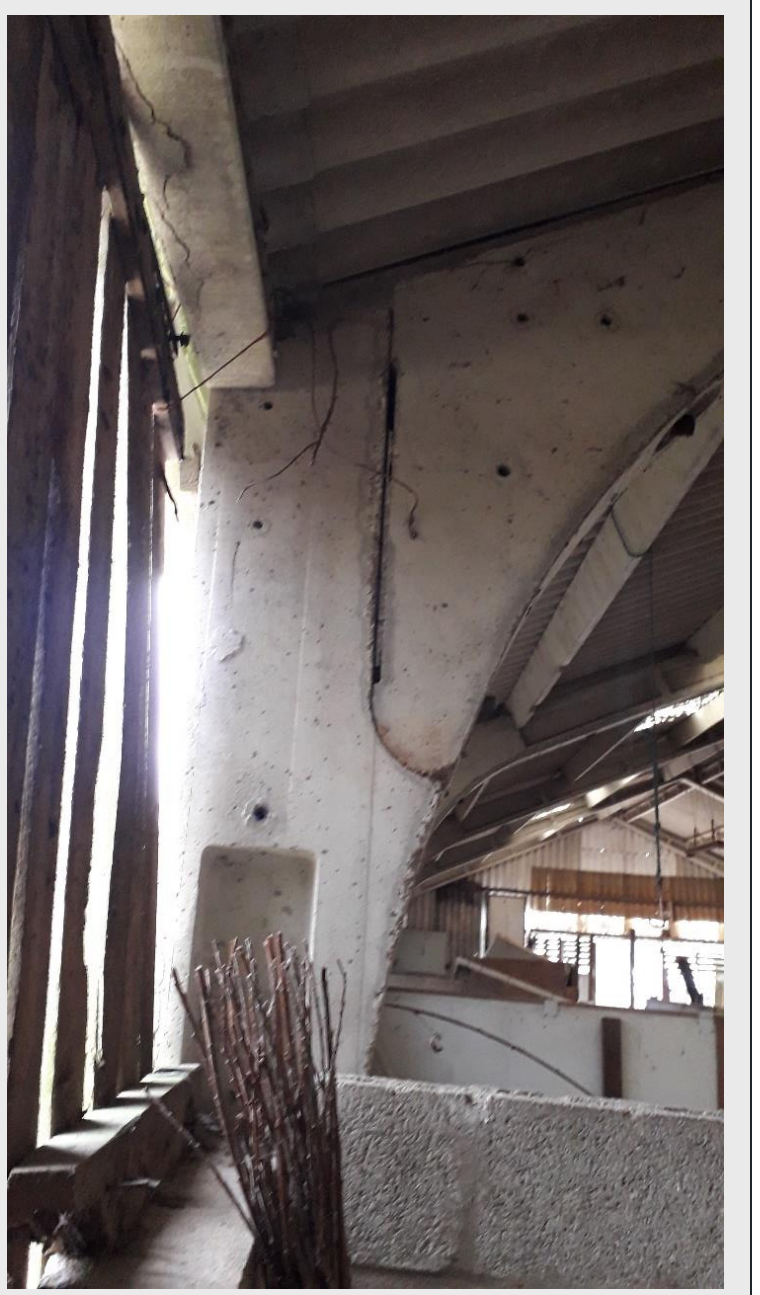
- Keeper's Cottage 1 – Image showing the inside of a former agricultural building, with exposed beams and breeze block low walls inside, and with low height internal walls. Currently used for storing vehicles/farm machinery.

Structure ref	Structure Description	Hibernation Survey Visit 1 Results	Hibernation Survey Visit 2 Results	Hibernation Roost Status	Structure Photograph
Keepers Cottage 1	Former agricultural building with corrugated asbestos roof support by steel and wooden A-frame on top of concrete pillars. Building has no external breeze block walls but has low height internal walls and is currently used for storing vehicles/farm machinery. Building very open to wind and light and has negligible suitability for roosting bats	05 March 2021 Building assessed as unsuitable to support hibernating bats, no second visit undertaken.	N/A	Unsuitable for hibernating bats.

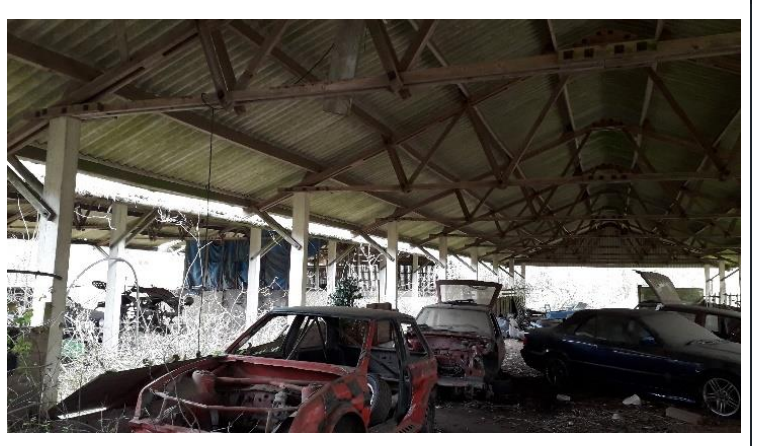
- Keeper's Cottage 2 – Image showing inside of former agricultural building with exposed beams and roof A-frames. Old, disused cars are shown as being stored inside.

Keepers Cottage 2	Former agricultural building with corrugated asbestos roof support by steel and wooden A-frame on top of concrete pillars. Building has no external breeze block walls but has low height internal walls and is currently used for storing vehicles/farm machinery. Building very open to wind and light and has negligible suitability for roosting bats	05 March 2021 Building assessed as unsuitable to support hibernating bats, no second visit undertaken	N/A	Unsuitable for hibernating bats.

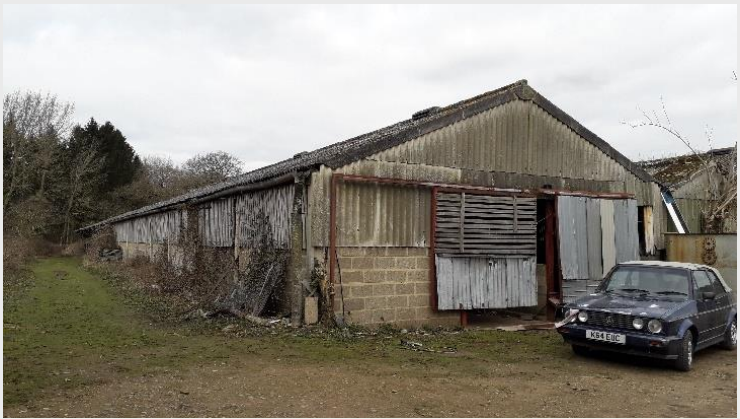
- Keeper's Cottage 3 – Image showing a former livestock building with corrugated asbestos roof with skylights, supported by concrete pillars and beams. An old car is parked outside the closed front entrance.
- Keeper's Cottage 4 - Image showing a former agricultural building with external walls and roof constructed of corrugated asbestos with concrete pillars and beams. There are two large doors, one half-open, and another entrance next to this wide-enough for cars/vehicles.

Structure ref	Structure Description	Hibernation Survey Visit 1 Results	Hibernation Survey Visit 2 Results	Hibernation Roost Status	Structure Photograph
Keepers Cottage 3	Former livestock building with corrugated asbestos roof with skylights, supported by concrete pillars and beams. Internal walls constructed of breeze block and external walls half height breeze block with wooden slats creating the top half. Building very well-lit through wooden wall slats and skylights with only crevices available where there are joins and cracks in the concrete pillars. Due to the high lighting levels, the building has negligible suitability for hibernating bats.	05 March 2021 Building not accessed due to absence of information regarding asbestos.	26 March 2021 Building accessed following asbestos survey. Assessed as unsuitable to support hibernating bats.	Unsuitable for hibernating bats.

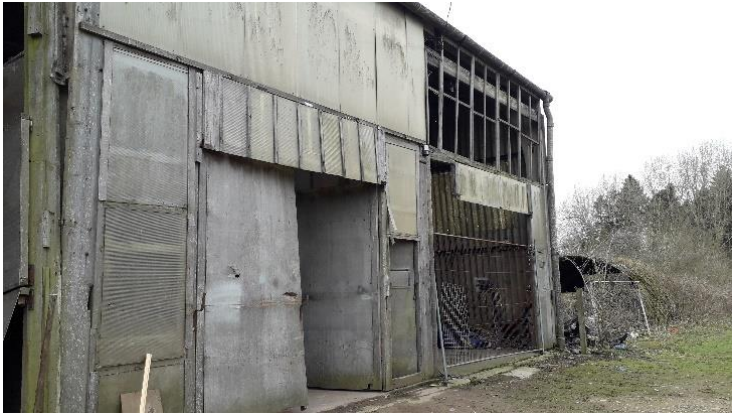
Keepers Cottage 4	Former agricultural building split into three parts. External walls and roof are constructed of corrugated asbestos with concrete pillars and beams. The east and west sides of the building are open fronted with skylights in the roof. East side used for storage/workshop and west side used for vehicle storage with a vehicle inspection pit. Central part of the building has plywood doors and is used as a vehicle paint/spray booth. No evidence of bats found during the surveys and buildings have limited suitability for hibernating bats due to light ingress and lack of crevice spaces.	05 March 2021 Building assessed as unsuitable to support hibernating bats, no second visit undertaken	N/A	Unsuitable for hibernating bats.

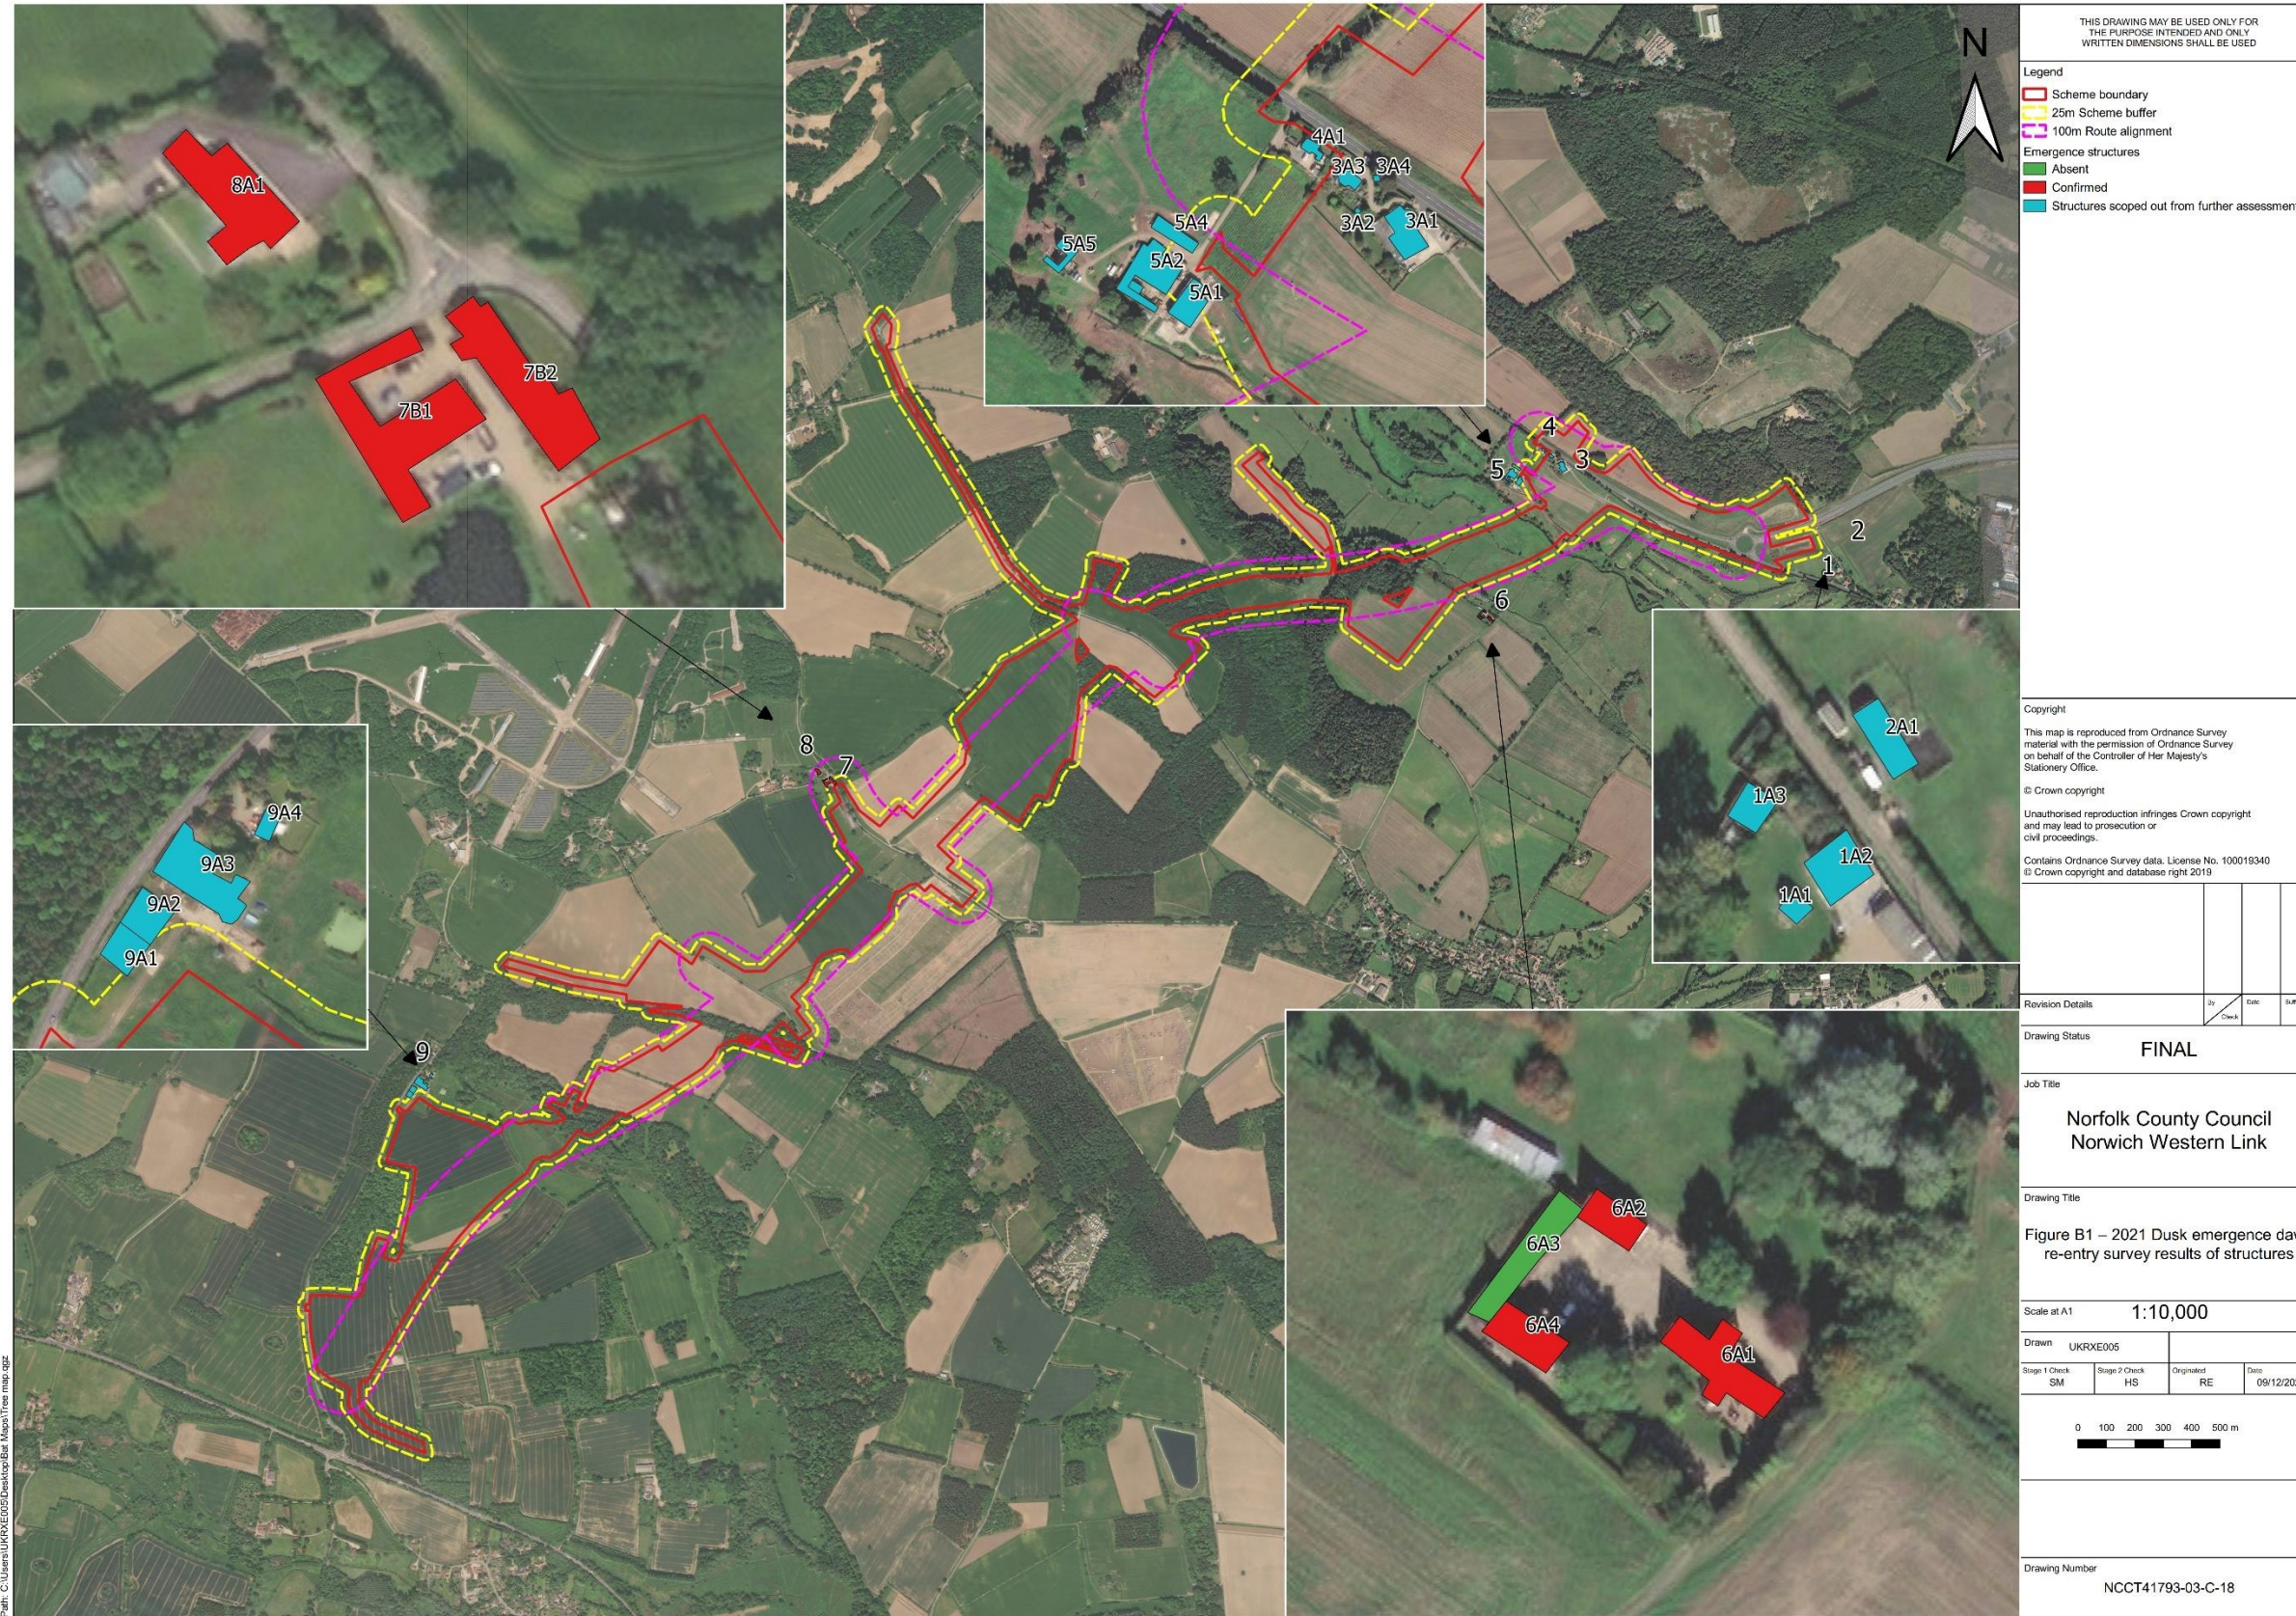
Figure B1 - 2021 Dusk emergence dawn re-entry survey results of structures

1.1.4 Figure B1 shows a map of the dusk emergence and dawn re-entry survey results of structures surveyed in 2021. The Site Boundary is displayed alongside the 25m Site buffer and 100m route alignment. All structures in proximity to the Site Boundary are displayed and categorised in relation to emergence. The categories are absent, confirmed and also includes structures scoped out from further assessment. 24 structures are displayed in total across the Site Boundary with structures with confirmed emergence located in the north-east area of the Site Boundary including The River Wensum and Grassland and also in The Hedgerows South of Weston Road.
