Norwich Western Link

Environmental Statement

Chapter 11: Bats

Appendix 3b: Structure Roosting Bats

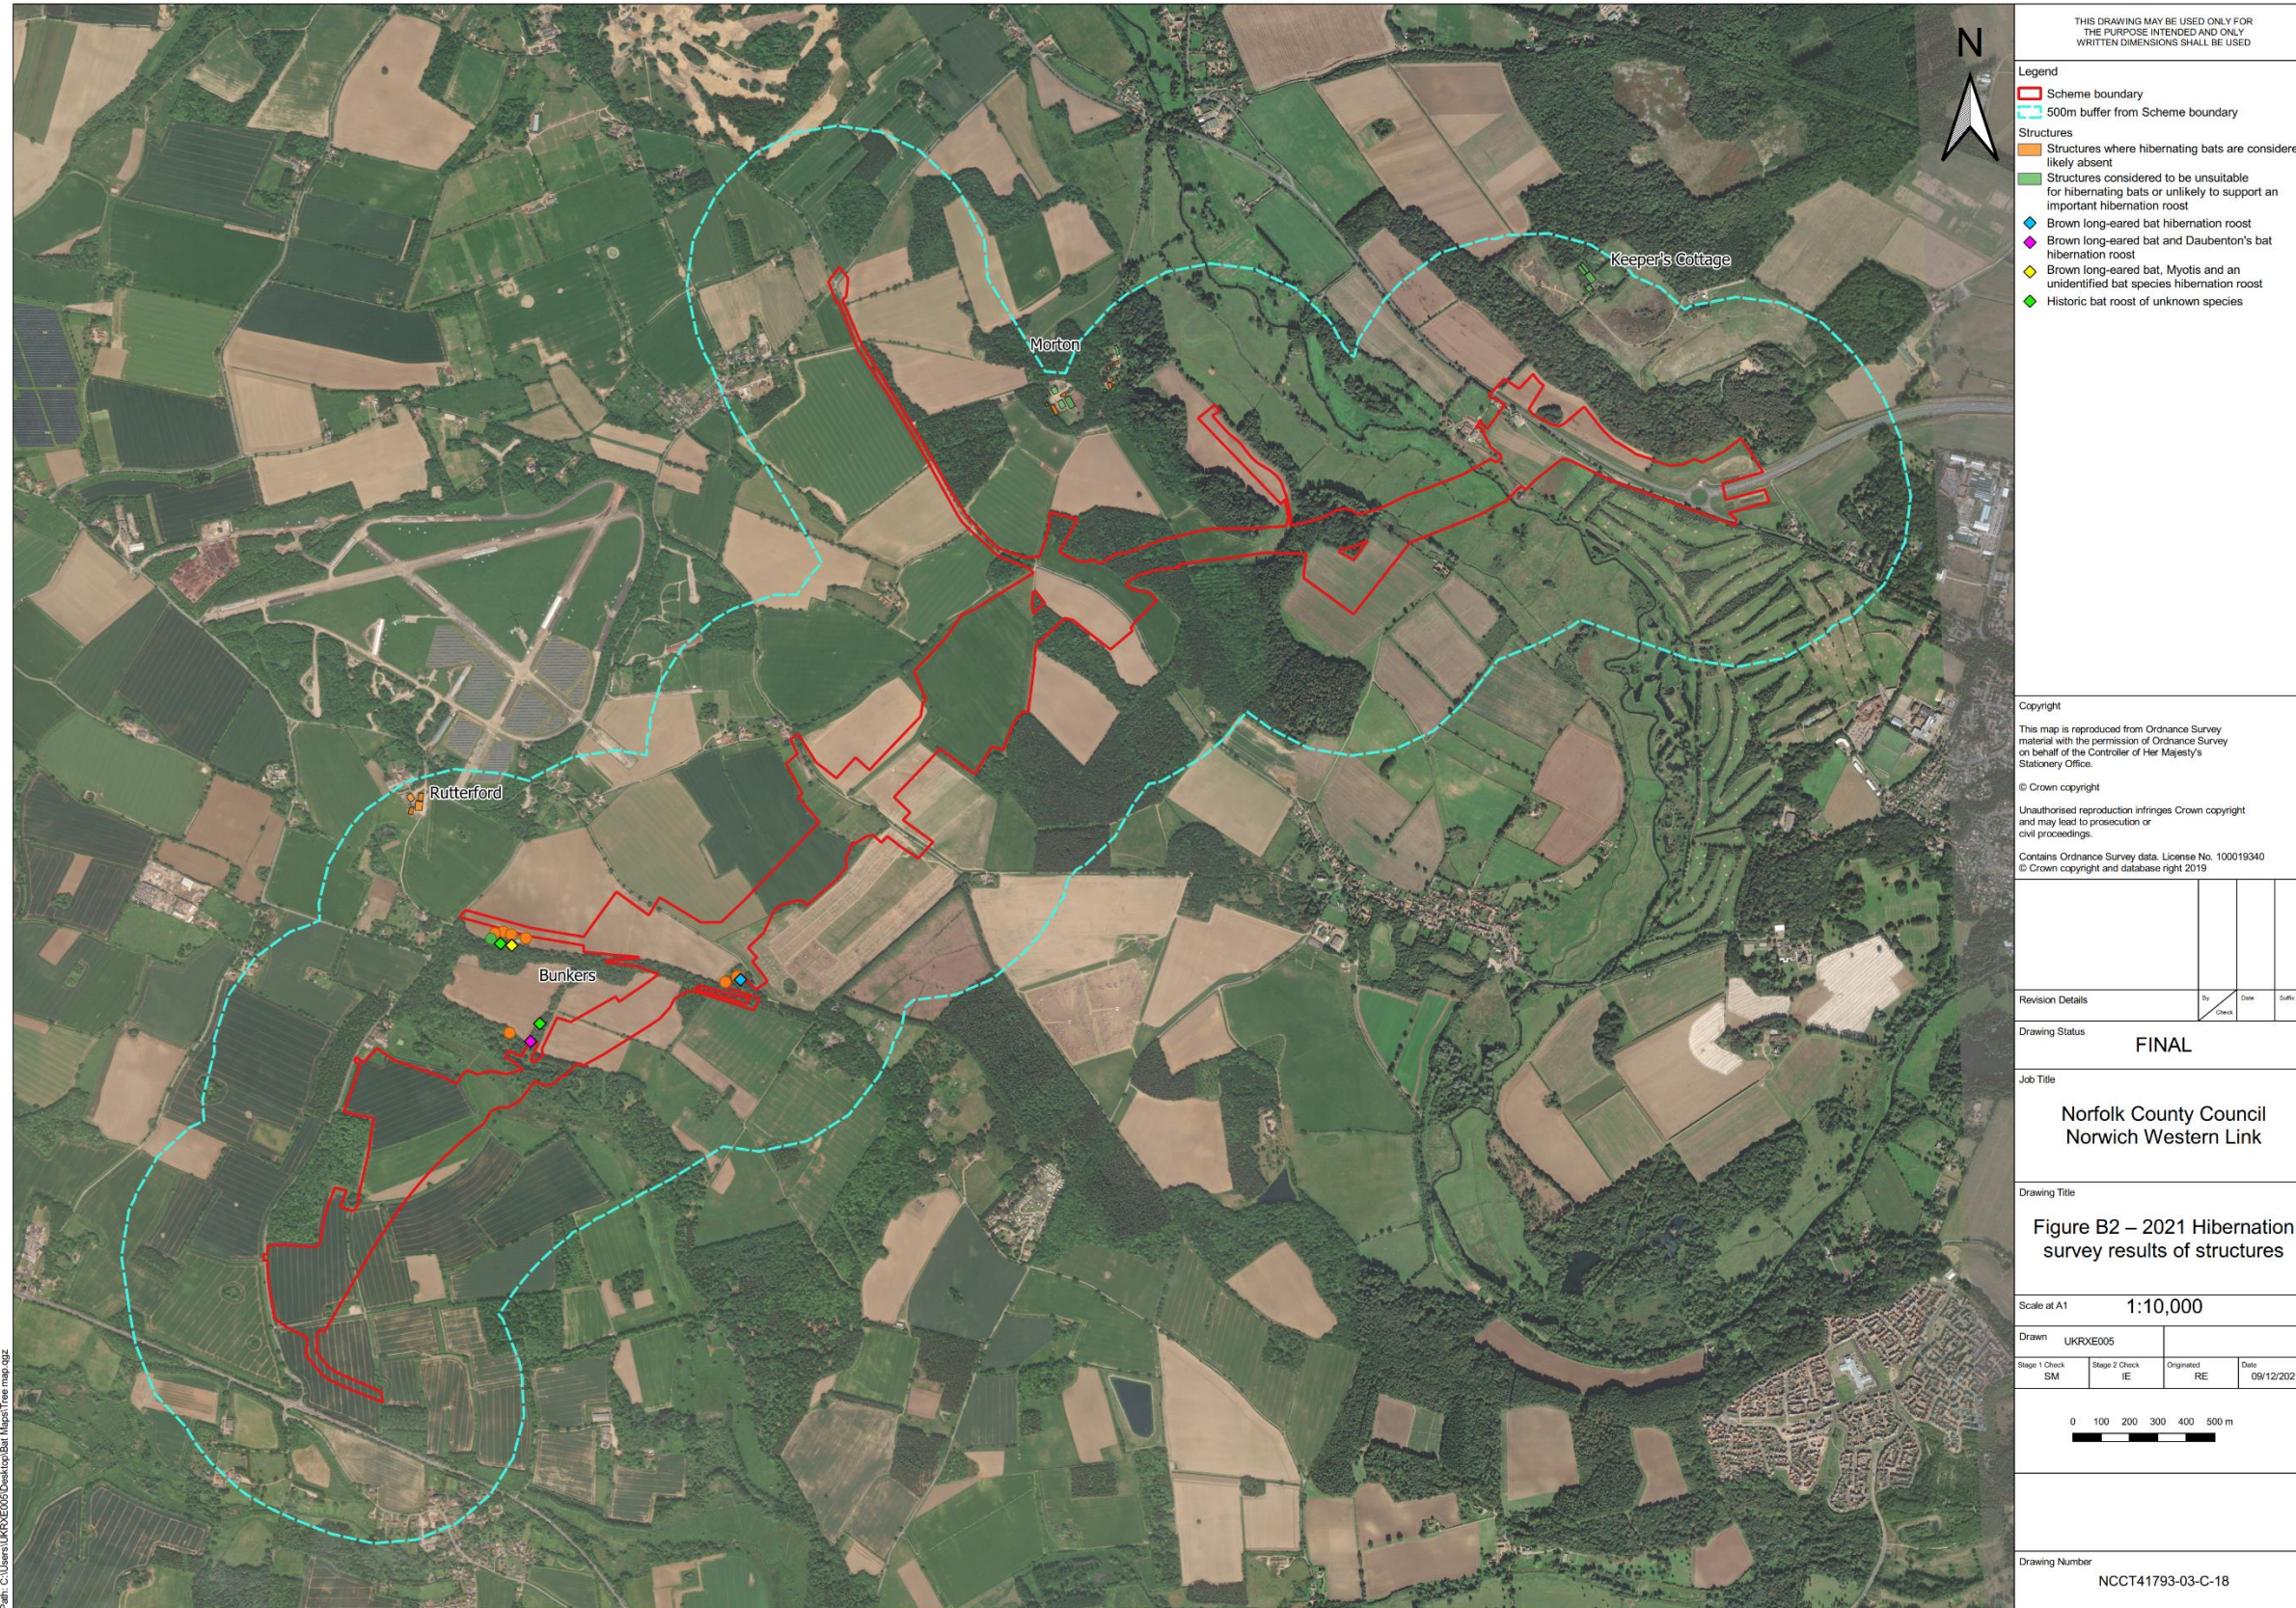
Figure B2 - 2021 Hibernation survey results of structures

1.1.5 Figure B2 shows a map of the hibernation survey results of structures surveyed in 2021. The Site Boundary is displayed, with an additional 500m buffer. Within the 500m buffer, structures are categorised in relation to firstly, if structures where hibernating bats are considered likely absent, or structures considered to be unsuitable for hibernating bats or unlikely to support an important hibernation roost. The remaining categories are in relation to brown long-eared bats (BLE) and are either where there is a BLE hibernation roost, a BLE and Daubenton's bat hibernation roost, a BLE, *Myotis* species and an unidentified bat species hibernation roost, or a historic bat roost of unknown species. On total, 5 hibernation roosts are displayed in total and are all located towards the south of the Site Boundary in proximity to The Broadway and Foxburrow Plantation. One is confirmed as a BLE bat hibernation roost,

one is confirmed as a BLE bat and Daubenton's bat hibernation roost and one is confirmed as a BLE bat, *Myotis* species and an unidentified bat species hibernation roost. The remaining two roosts are historic bat roosts of unknown species. This is also in the same area as a number of bunkers also displayed and categorised, with seven bunkers where hibernating bats are considered likely absent and one bunker considered to be unsuitable for hibernating bats or unlikely to support an important hibernating roost.

- 1.1.6 There are 24 structures displayed in total. These structures displayed include the location labelled Keeper's Cottage to the north of the Site Boundary and within the 500m buffer, where four structures are considered to be unsuitable for hibernating bats or unlikely to support an important hibernating roost. The location labelled Morton includes a total of 16 structures, eight of which are considered to be unsuitable for hibernating bats or unlikely to support an important hibernating roost. The remaining eight structures are where hibernating bats are considered likely absent. The remaining structures displayed include the location labelled Rutterford to the west of the Site Boundary and within the 500m buffer, where there are four structures where hibernating bats are considered likely absent.

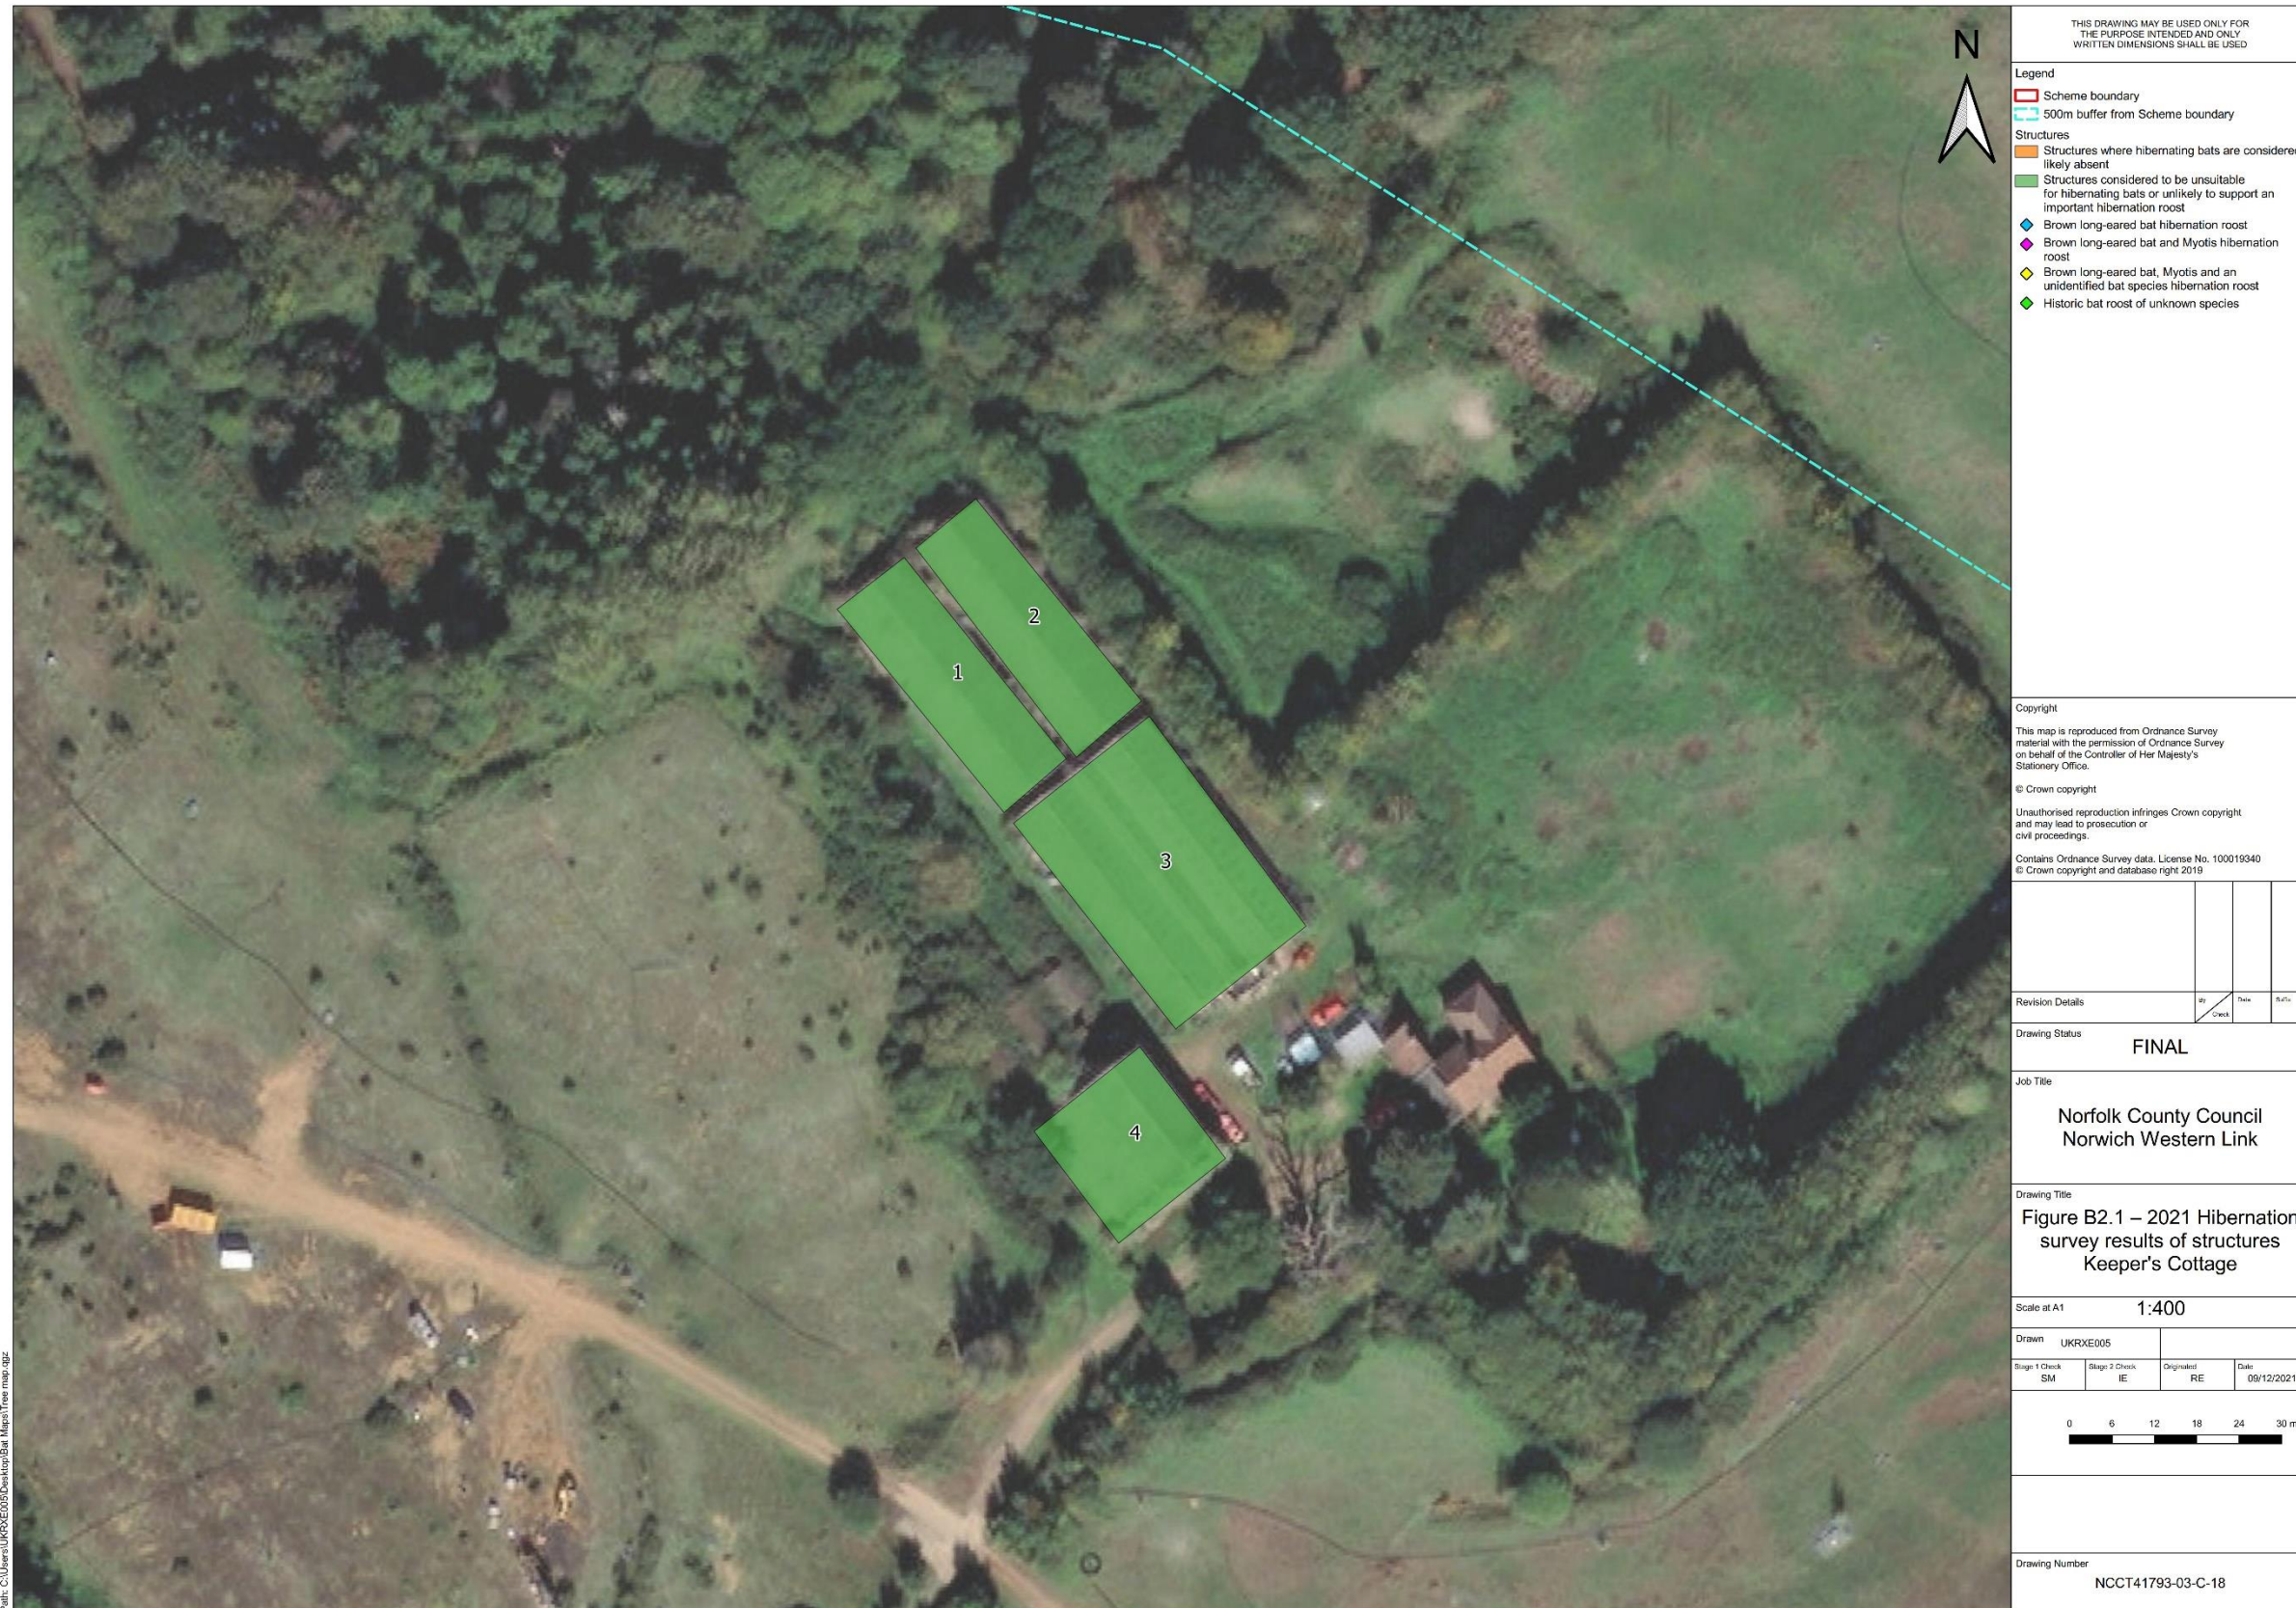
Figure B2.1 - 2021 Hibernation survey results of structures Keeper's Cottage

- 1.1.7 Figure B2.1 shows a map of the location labelled Keeper's Cottage to the north of the Site Boundary and within the 500m buffer, where four structures are considered to be unsuitable for hibernating bats or unlikely to support an important hibernating roost.

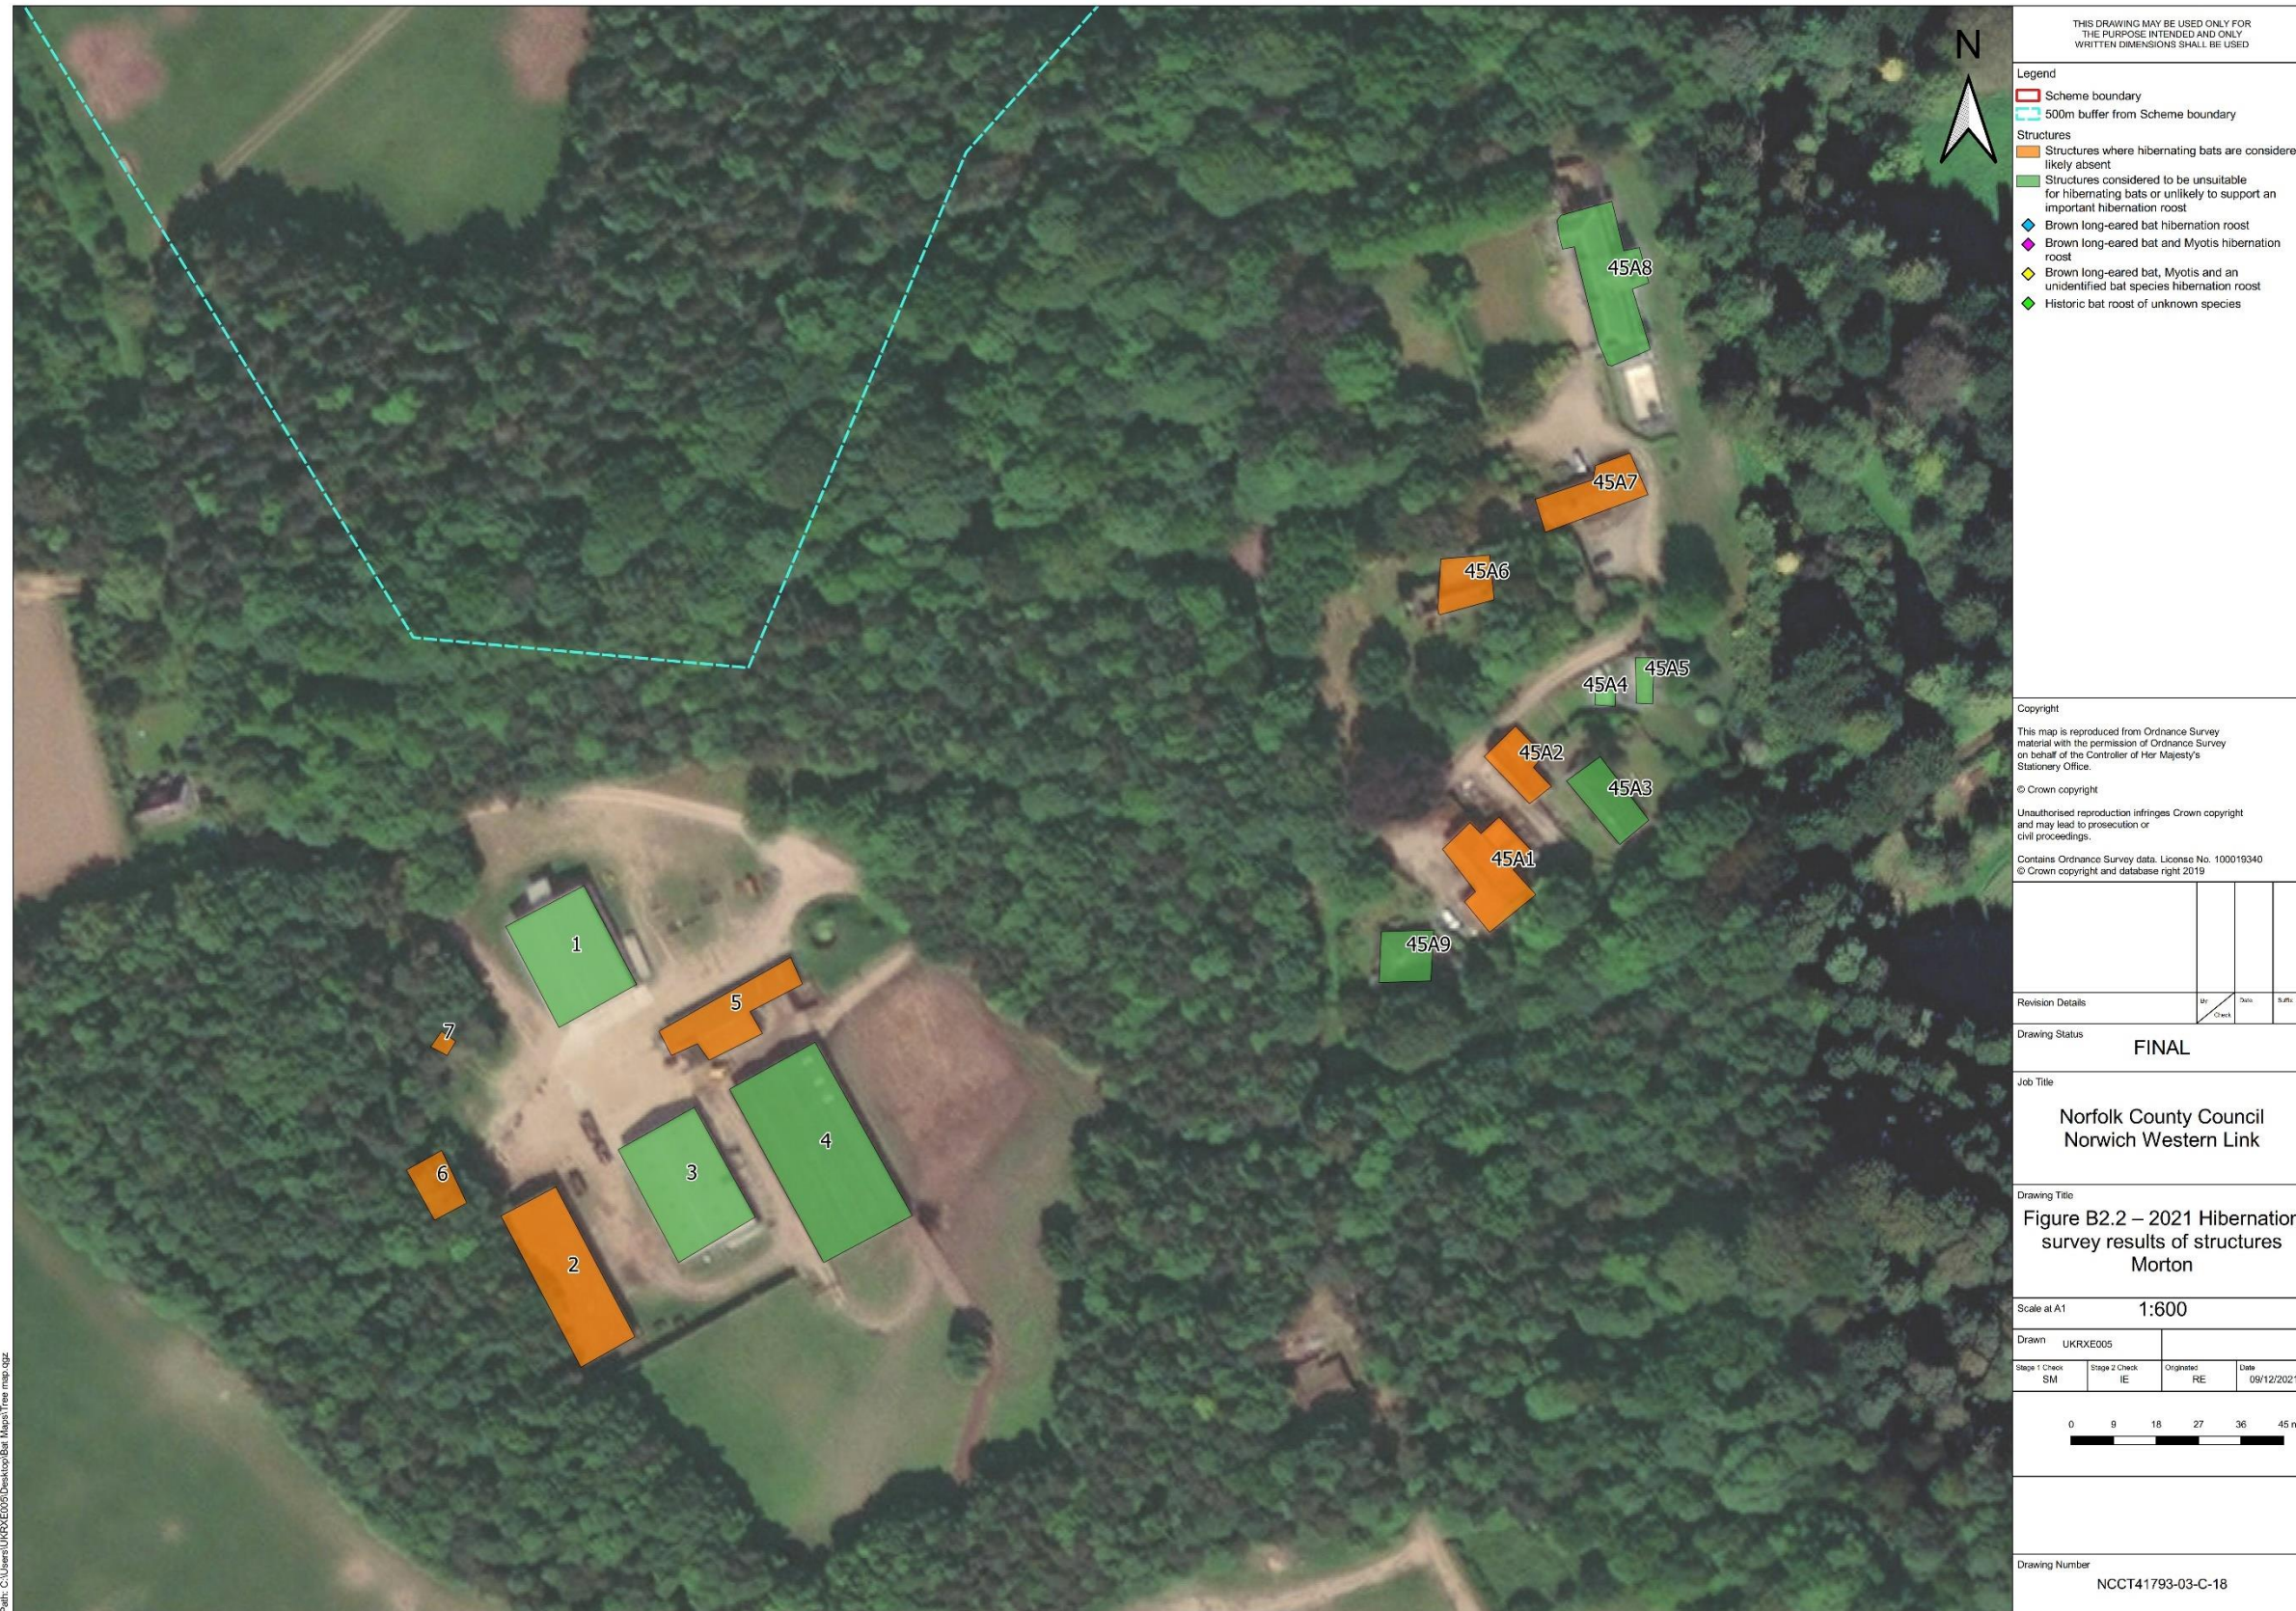
Figure B2.2 – 2021 Hibernation survey results of structures Morton

- 1.1.8 Figure B2.2 shows a map of the 2021 Hibernation survey results of structures of the location labelled Morton, where there are 16 structures. Eight of these structures are considered to be unsuitable for hibernating bats or unlikely to support an important hibernating roost. The remaining eight structures are where hibernating bats are considered likely absent.

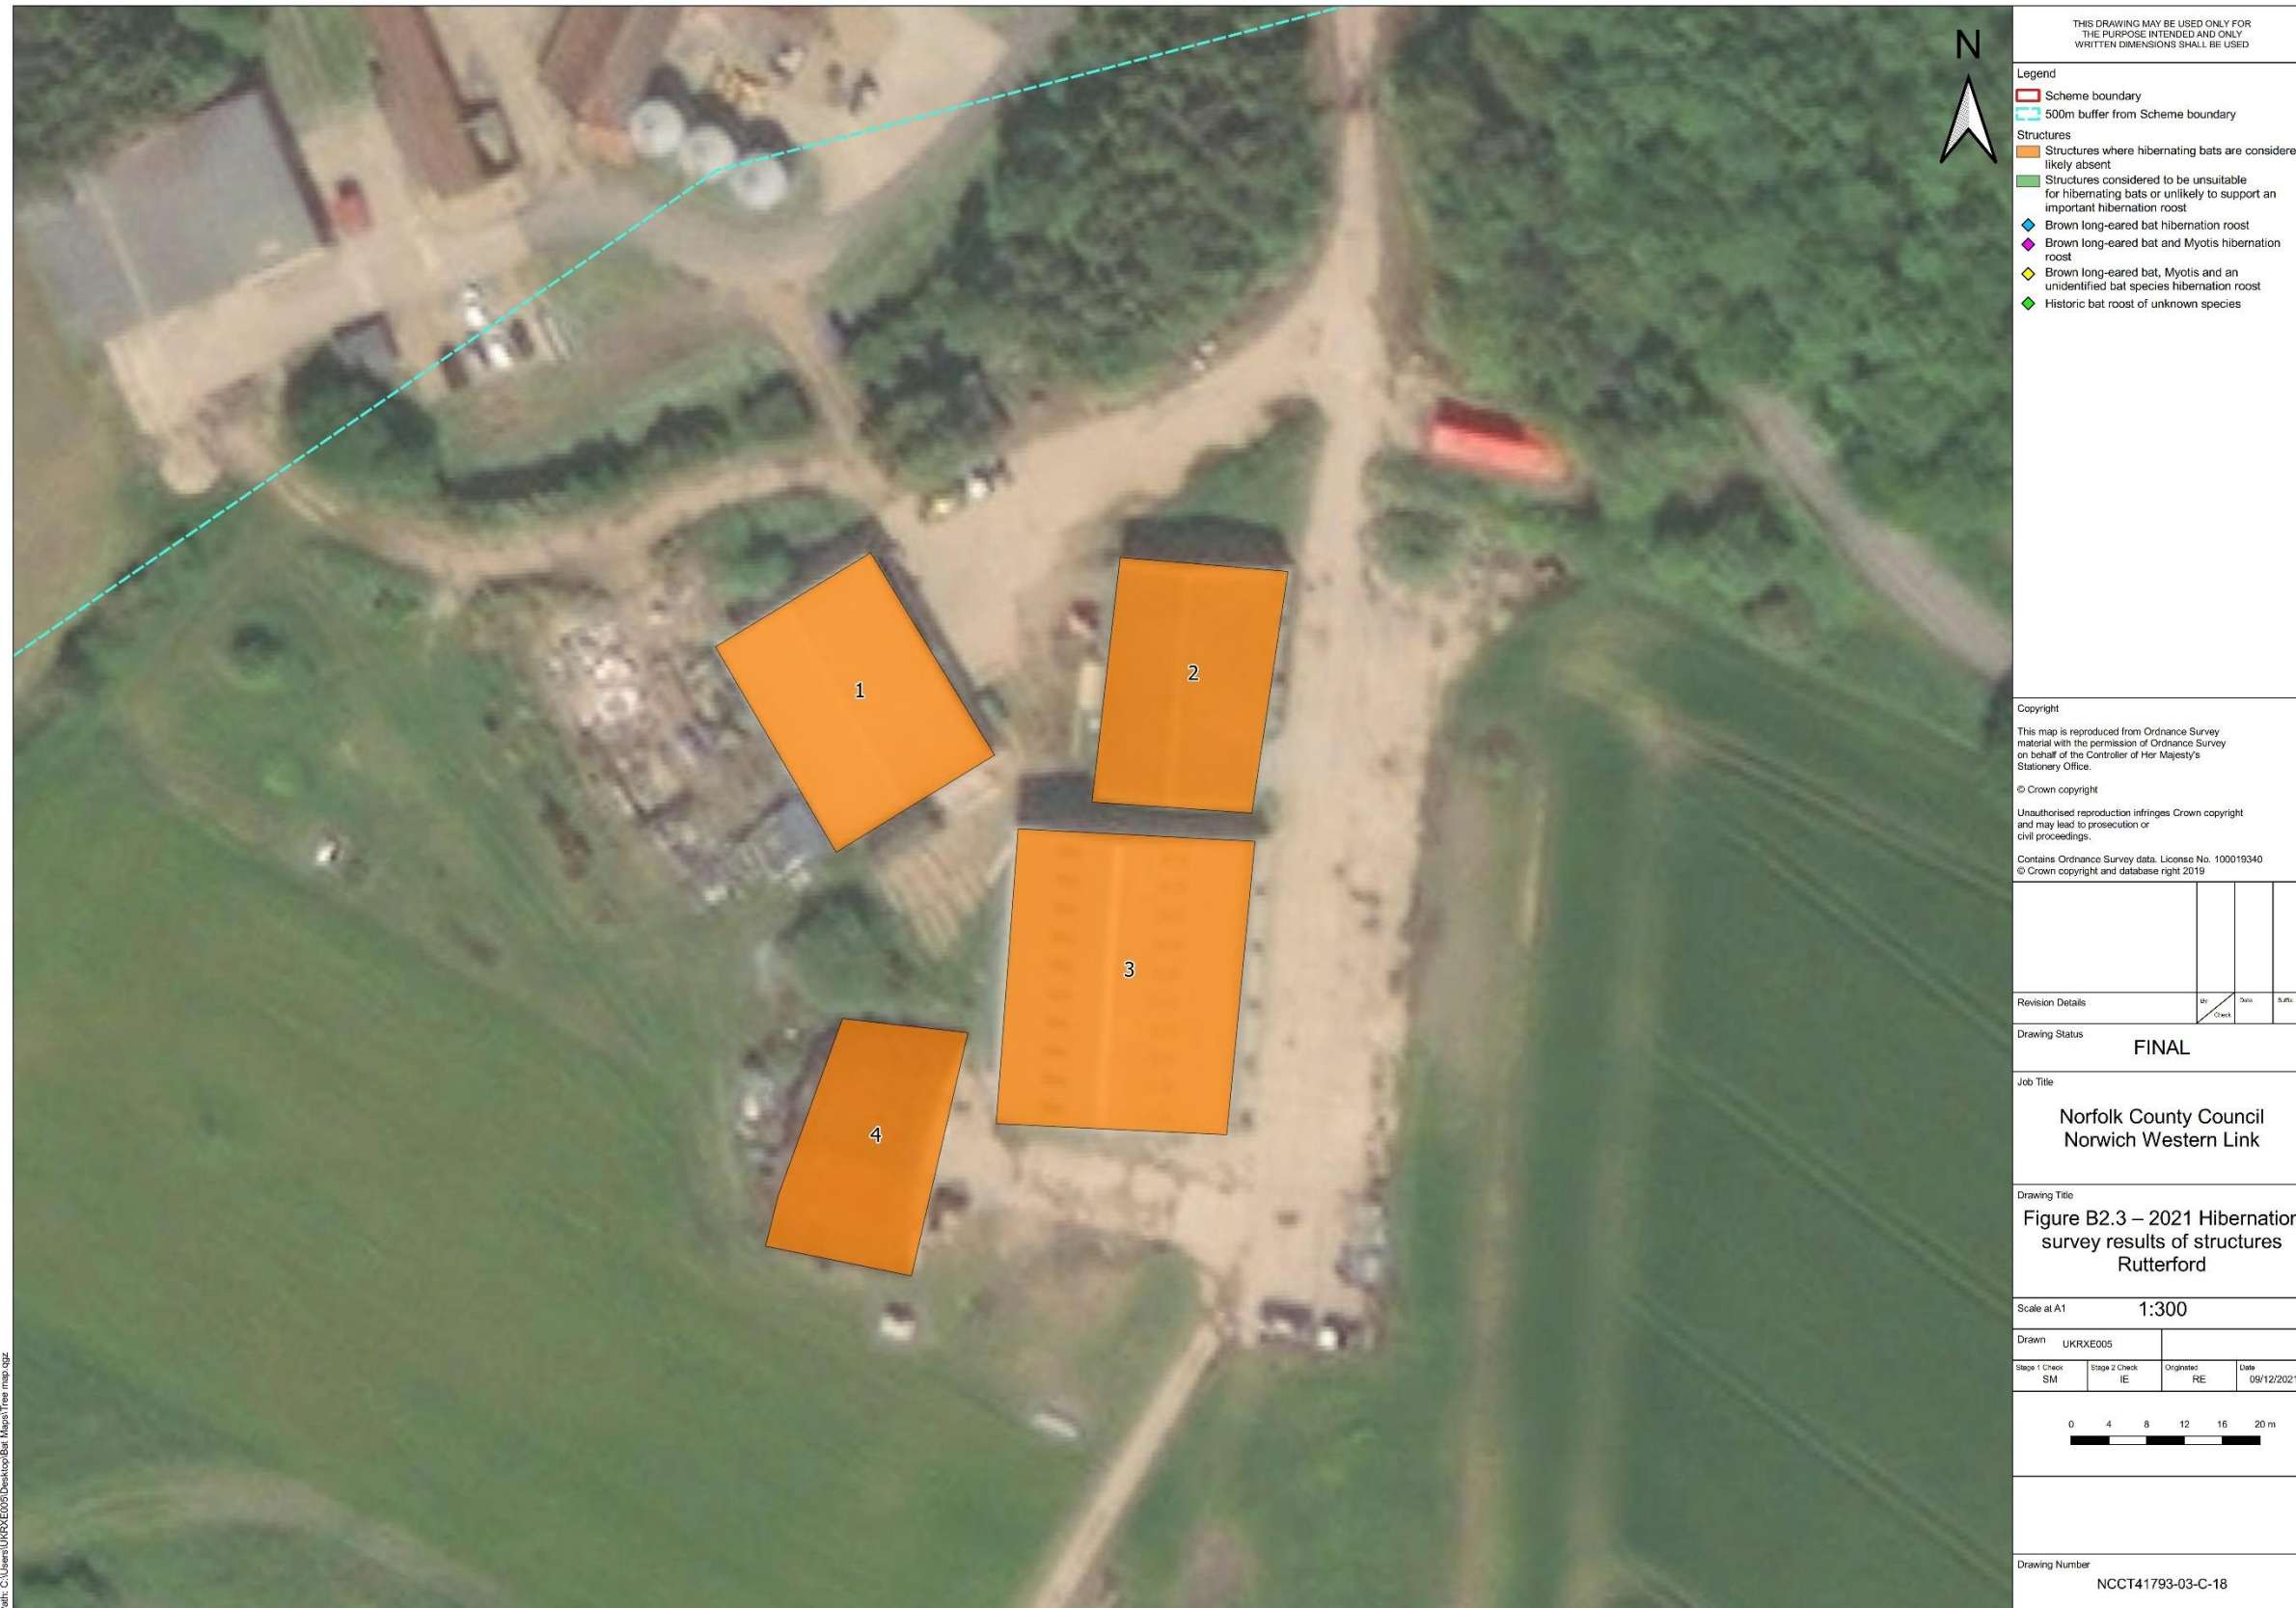
Figure B2.3 – 2021 Hibernation survey results of structures Rutterford

- 1.1.9 Figure B2.3 shows a map of the 2021 hibernation survey results of structures of the location labelled Rutterford to the west of the Site Boundary and within the 500m buffer, where there are four structures where hibernating bats are considered likely absent.

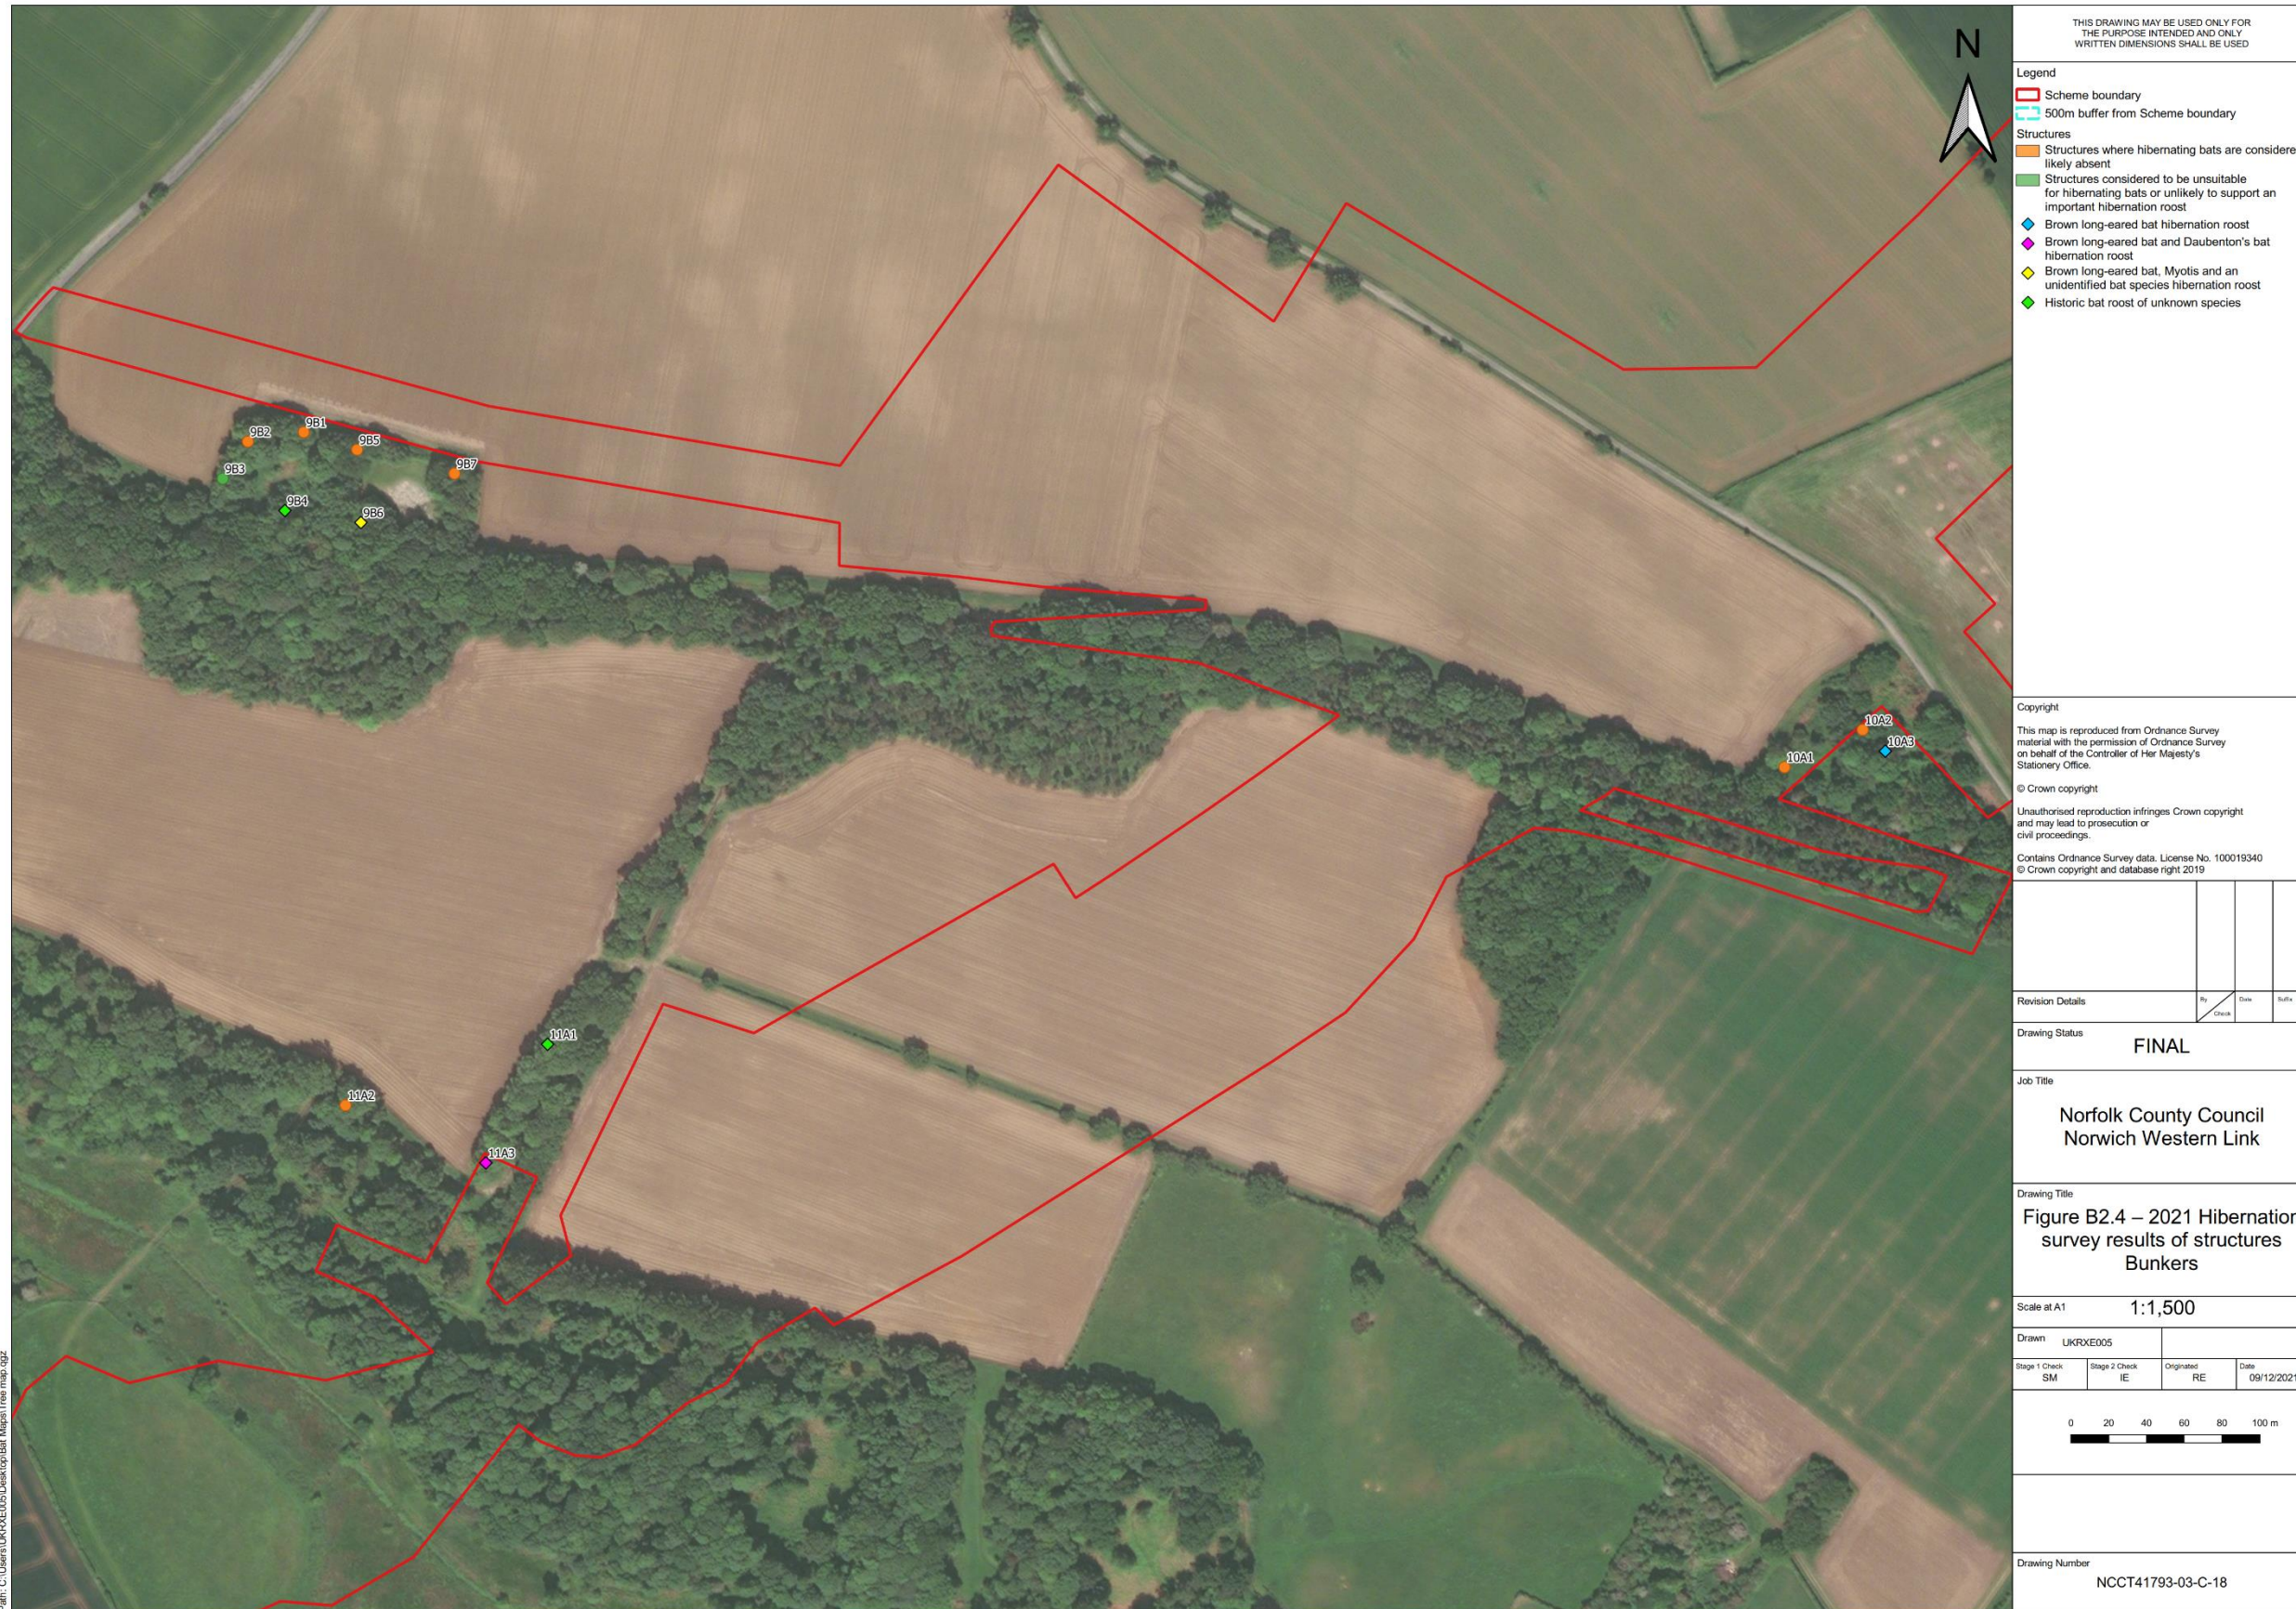
Figure B2.4 – 2021 Hibernation survey results of structures Bunkers

- 1.1.10 Figure B2.4 shows a map of the 2021 hibernation survey results of structures of the location labelled Bunkers. These are a number of bunkers displayed and categorised, with seven bunkers where hibernating bats are considered likely absent and one bunker considered to be unsuitable for hibernating bats or unlikely to support an important hibernating roost. The map also displays the confirmed roosts, including the 5 hibernation roosts that are displayed in total. These are all located towards the south of the Site Boundary in proximity to The Broadway and Foxburrow Plantation. One is confirmed as a BLE bat hibernation roost, one is confirmed as a BLE bat and Daubenton's bat hibernation roost and one is confirmed as a BLE bat, *Myotis* species and an unidentified bat species hibernation roost. The remaining two roosts are historic bat roosts of unknown species.
