Norwich Western Link

Drainage Strategy Appendix 14 : Ground Investigation Reports Part 1 of 8

Document Reference: 4.04.14

Ground Investigation Report

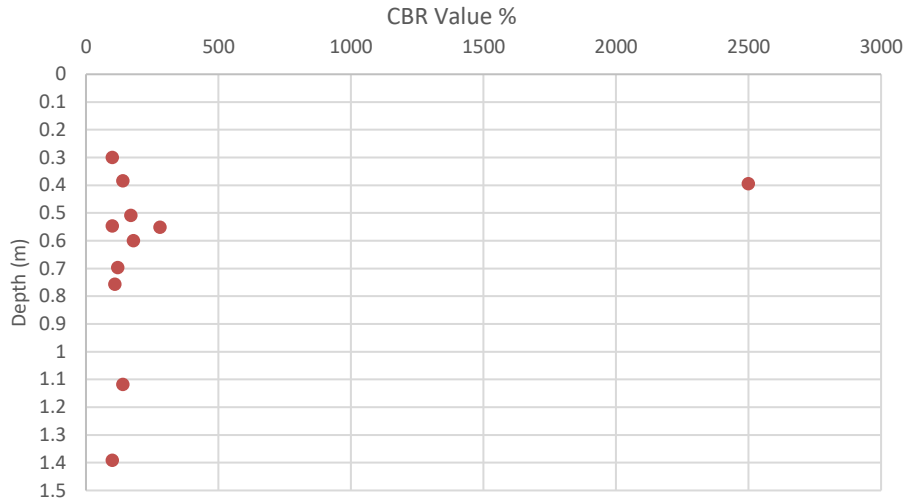
Figure 3.4.2b: Graphical summary of CBR values between 100-2500% vs Depth.

Further analysis of the dataset presented within figure 3.2.4b above indicates that all the elevated results were associated with DCP203, DCP203A, DCP206 and DCP214 with the value of 2500% associated with DCP203 at the depth of termination.

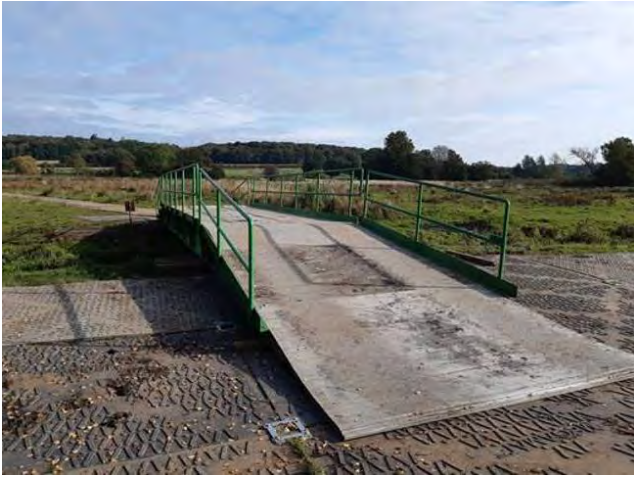
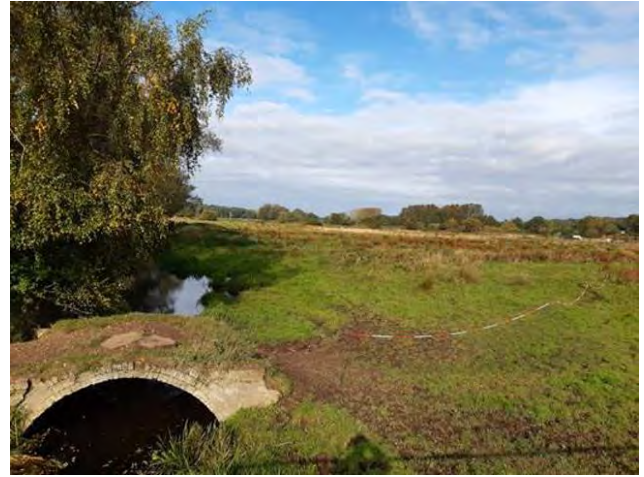
Figure 5-2 River Wensum floodplain – Photos were taken on 14/10/2021

Flooding from the River Wensum in the vicinity of the NWL scheme is confined mainly to the surrounding wet grassland and open green space. Furthermore, flooding was noted during the 2019/2020 Preliminary and 2021 Supplementary Stage 1 GI. Figure 5-2 and Figure 5-3 are photos of the floodplain taken during the 2021 GI, where the water level rose circa. 0.20 to 0.25m above ground level following two days of rain.

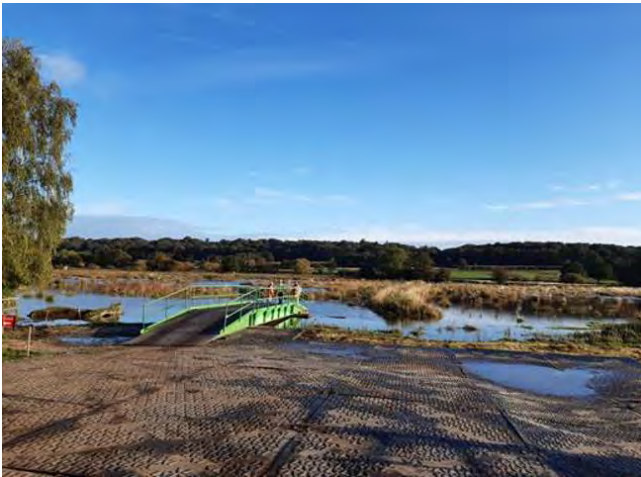
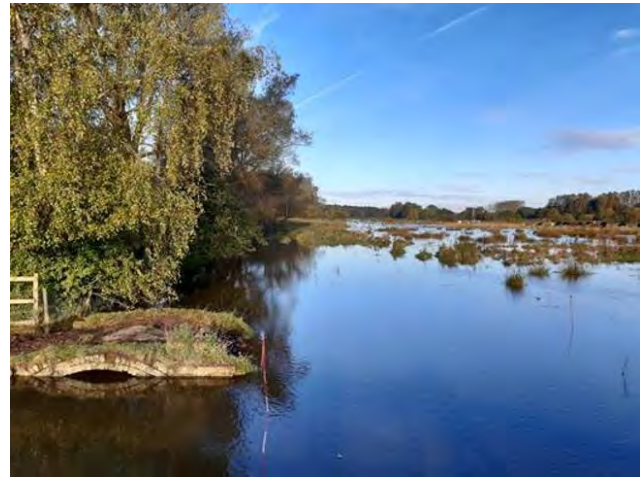
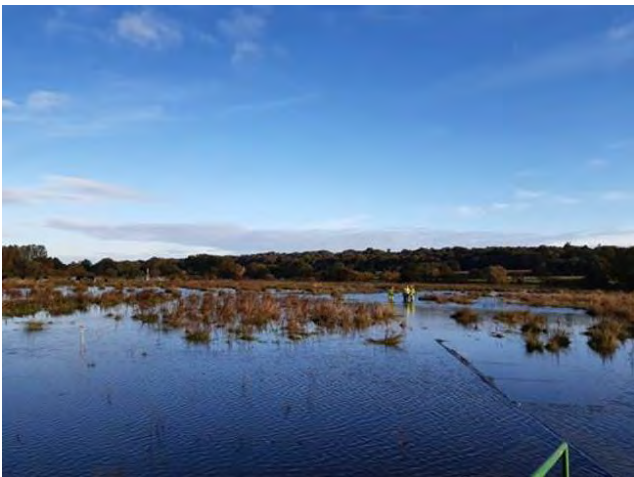
Figure 5-3 River Wensum floodplain - Photos were taken on 22/10/2021

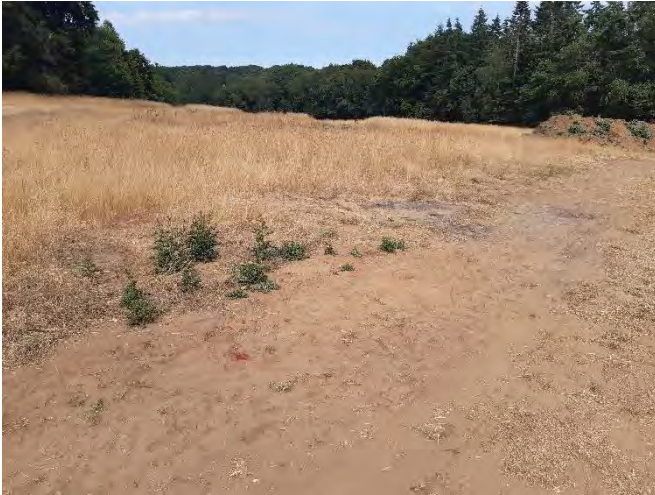
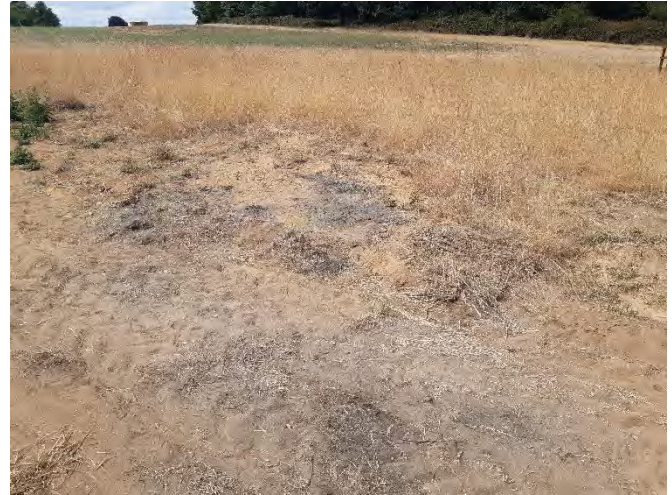
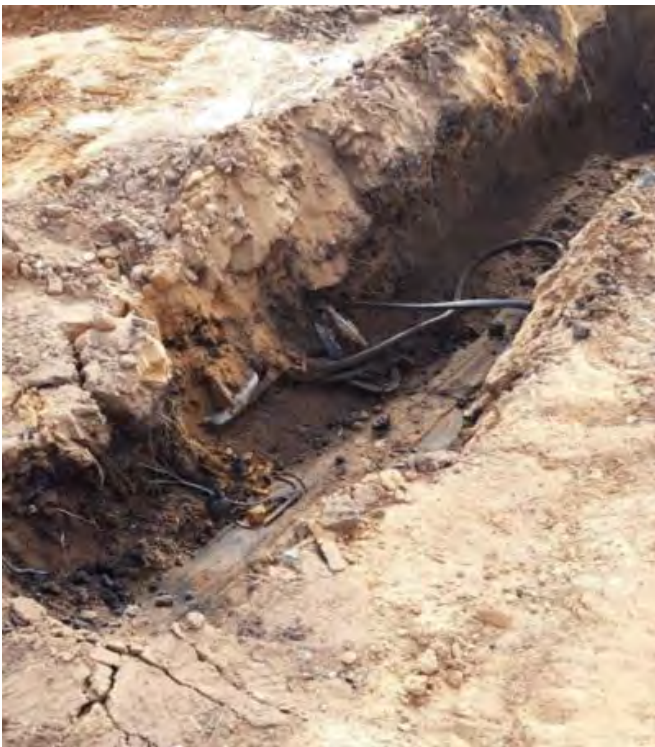
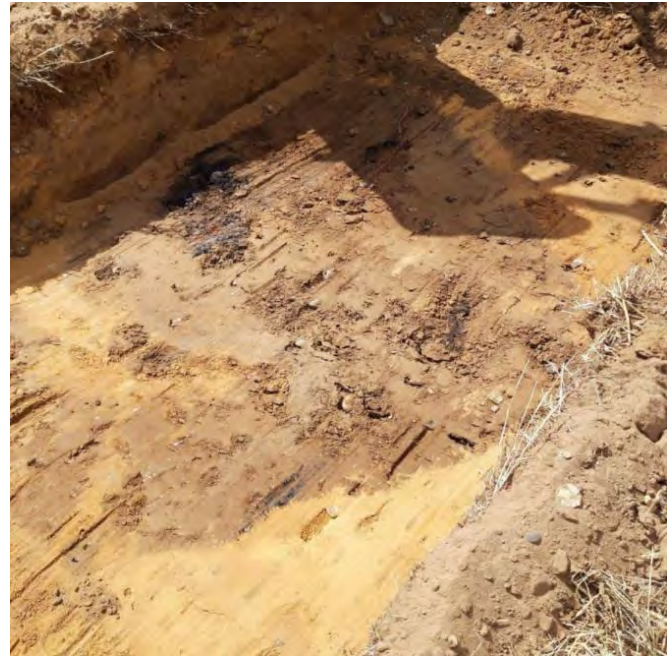
Figure 7-1 Backfilled waste pit at TR204 and TR205

Potentially waste-impacted soil was encountered near mainline CH1130 and the RW1 Ancient Woodland Retaining Wall during the archaeological investigation in 2022. Subsequently, additional intrusive investigations were completed as part of the Alignment Refinement GI to determine the extent and depth of the impacted soil. These are TR204 and TR205. Dark brown gravelly SAND was encountered with frequent pockets of black ash, burnt wood, charcoal, electrical cables, plastic and ropes. See Figure 7-1. The location is likely used as a waste pit and has been backfilled at the time of the investigation. The depth of the impacted soil was proven in TR205HP to be 1.10m deep. Additional photograph records at TR204 and TR205 are available in Appendix 5.

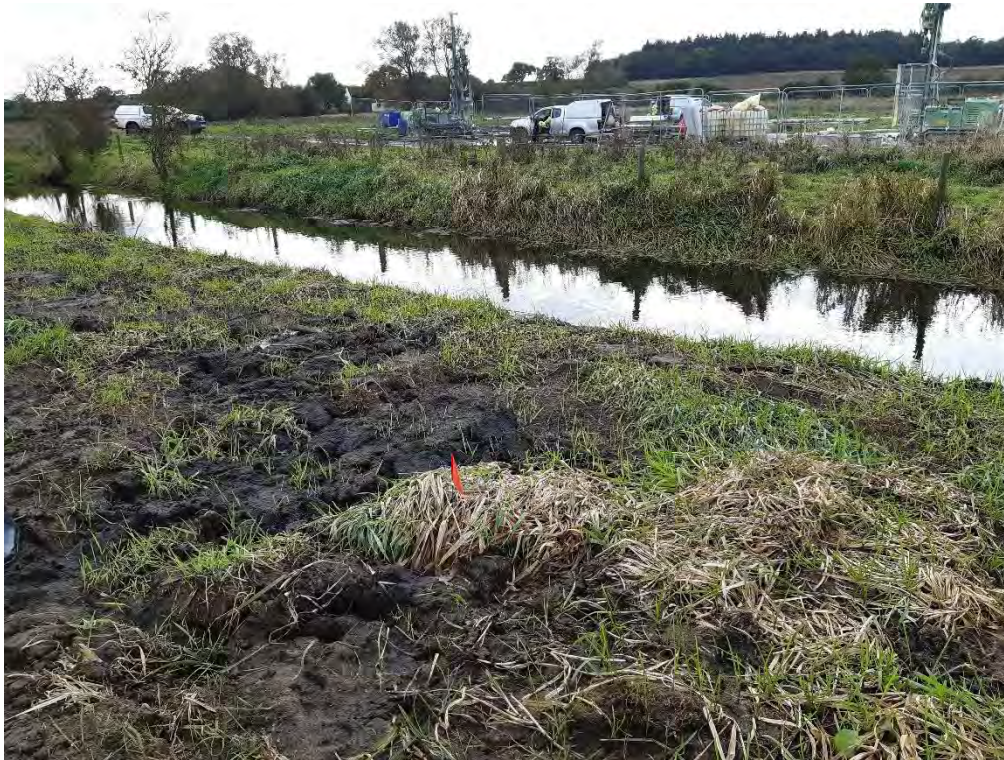
Figure 7-2 Peat on the River Wensum floodplain noted during the 2021 Supplementary Stage 1 GI.

Peat was locally encountered in exploratory holes on the River Wensum valley floodplain, typically found at locations on either side of the river and parts of the floodplain extending south from the river. The Peat encountered is generally formed of accumulated dead vegetation in various decomposition stages. This accumulation was observed to be particularly significant near a water reservoir which promotes growth and preserves the plant remains, see Figure 7-2 and Figure 7-3.

Based on the environment in which the Peat was encountered, the formation can be categorised as a Fen, predominantly fed by groundwater or flowing water sources. A review of the material descriptions shows pseudo-fibrous Peat is the dominant material type, and amorphous Peat was occasionally found. This suggests there is limited to no recognisable plant structure in the Peat and no strength of the apparent plant material. The condition is typically recorded as spongy, indicating it is very compressible with an open material structure.

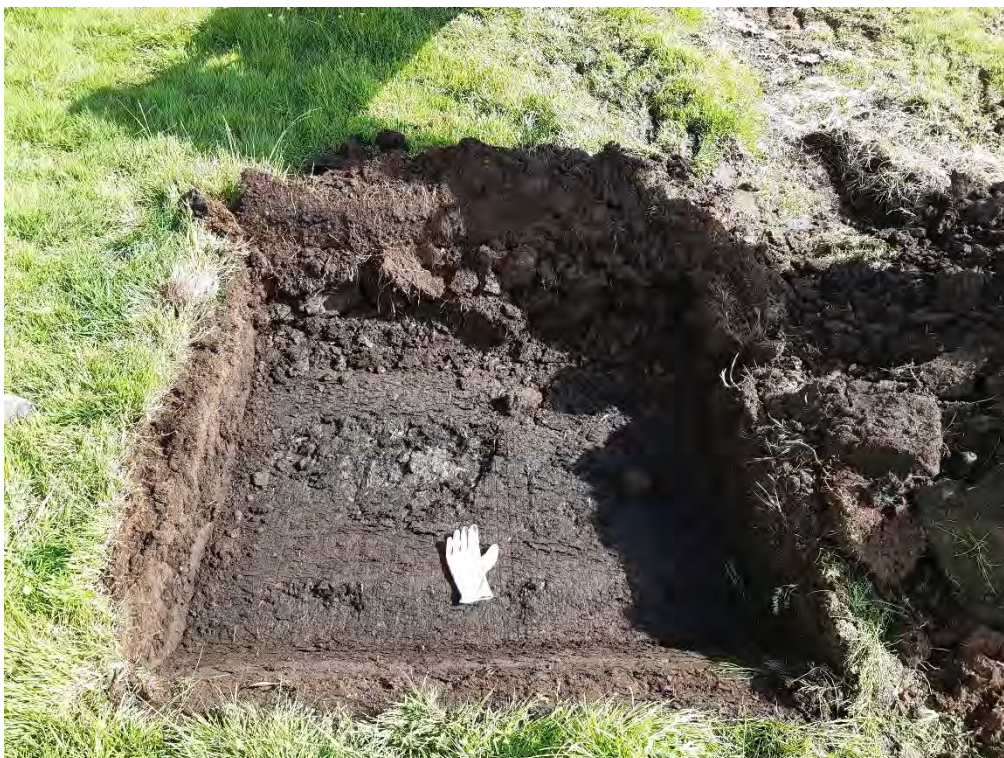
Figure 7-3 Peat encountered at TP247A during the 2022 Alignment Refinement GI

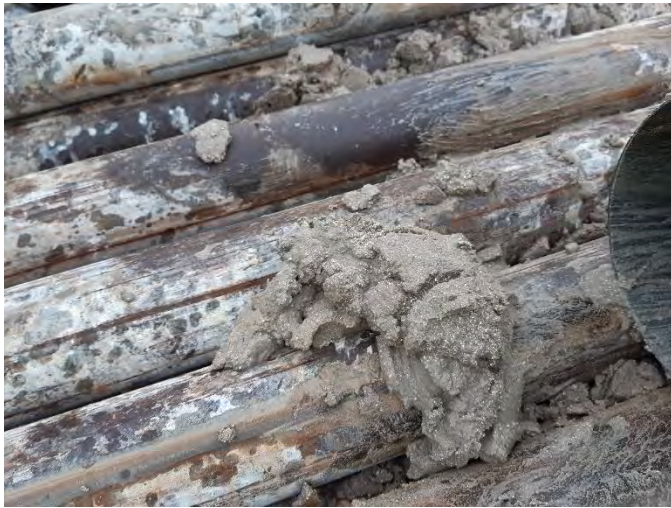
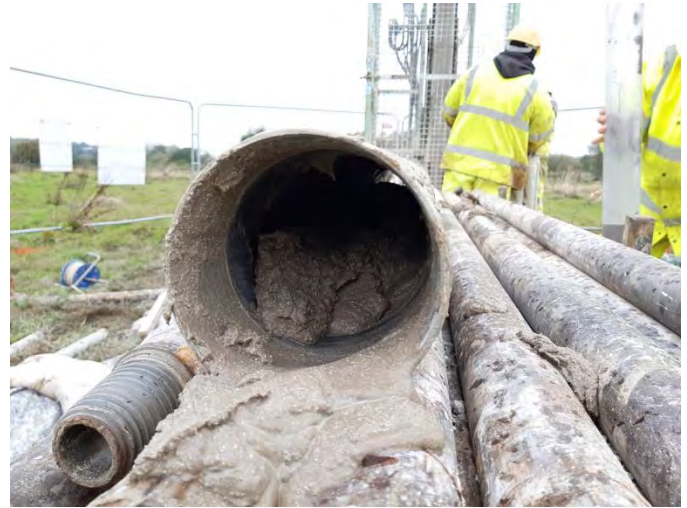
Figure 7-4 Dissolution feature infill at BHR13 between 49.0 to 50.0 mbgl

Figure 7-4 and Figure 7-5 are photos of dissolution features taken at BHR13 and BHR14. The factual report NCCT41793-HAG-VGT-FSC-RP-GI-0001 and the exploratory hole logs should be referred to for further detail. Although the holes are about 120m away from the realigned mainline, dissolution features remain a significant hazard on the River Wensum Valley floodplain. They present the risk of additional settlements and reduction in pile capacities. In addition, the risk of multiple nearby features forming a single larger one should be assessed during detailed design. The designer should be notified if a dissolution feature is encountered during construction.

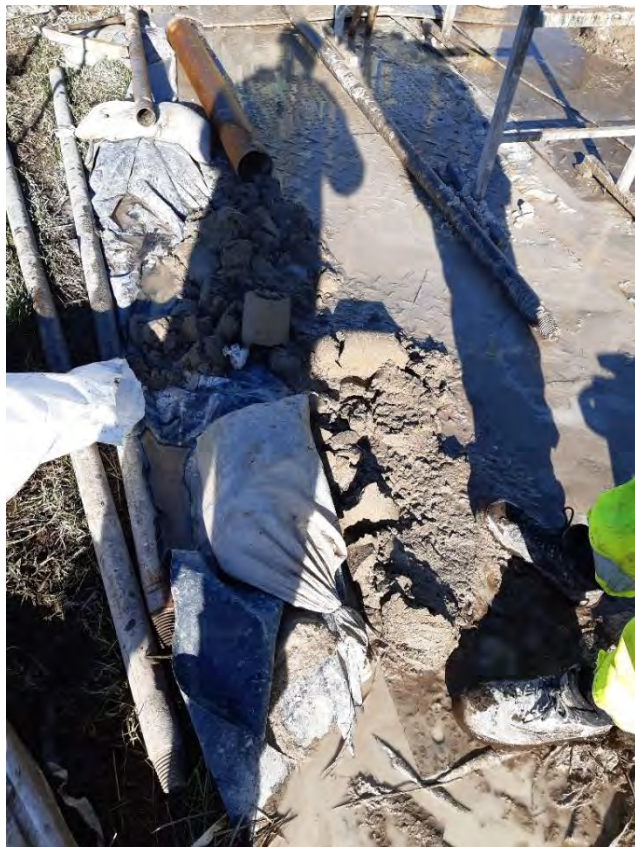
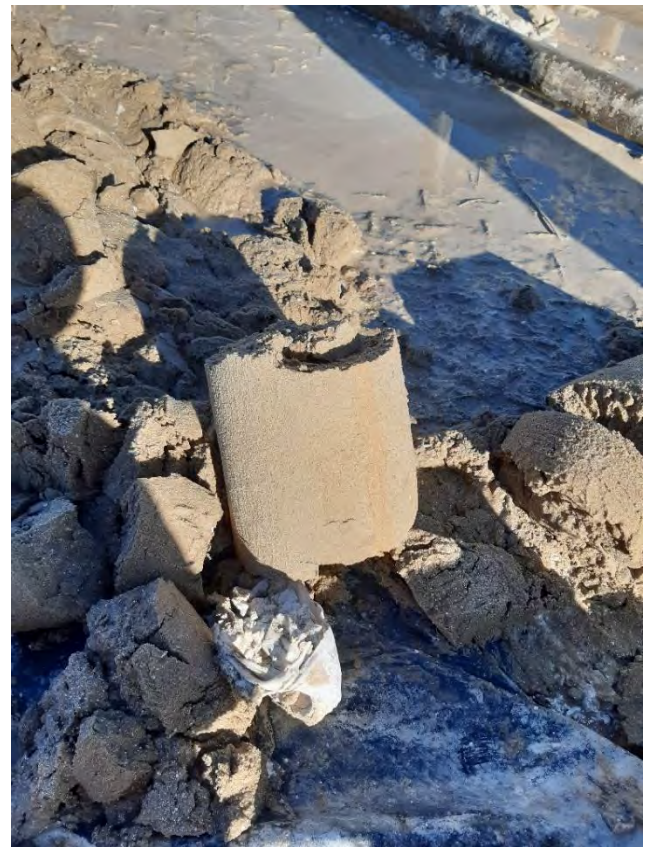
Figure 7-5 Dissolution feature infill at BHR14 between 10.5 to 11.3 mbgl
