Norwich Western Link

Environmental Statement

Chapter 12: Road Drainage and the Water Environment

Sub Appendix D: River Condition Indicators and Enhancement Concepts

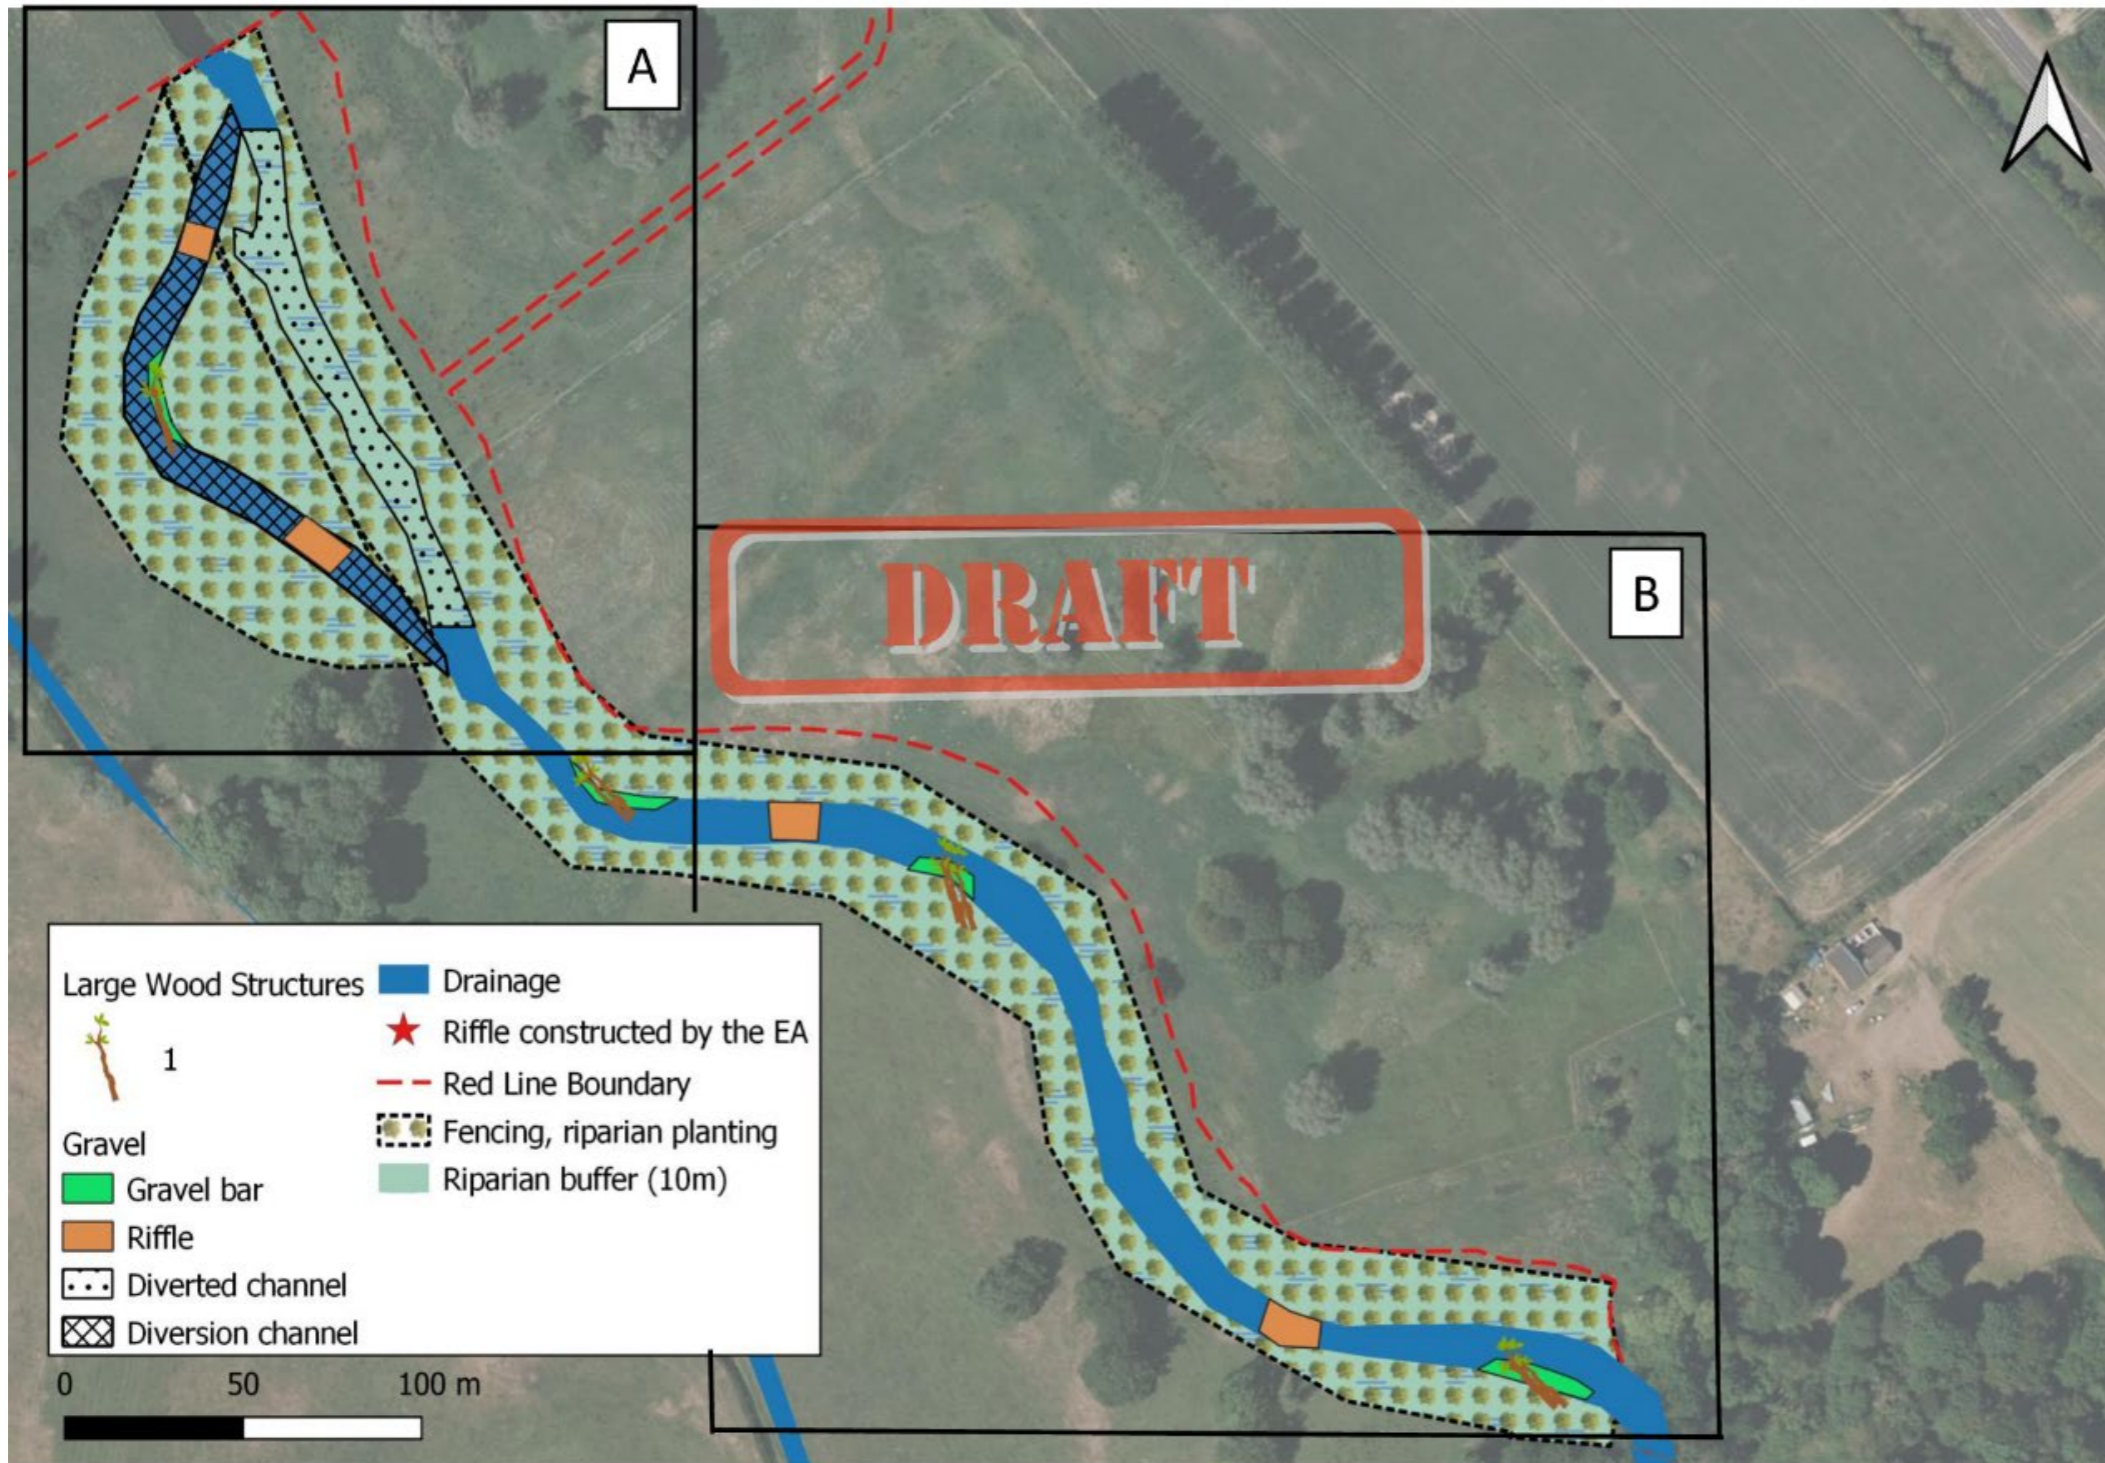
Figure D-1 Concept design overview of the proposed enhancements (subject to feasibility) for the River Wensum

Morton Estate – Overview of possible enhancement for improving biodiversity on the River Wensum

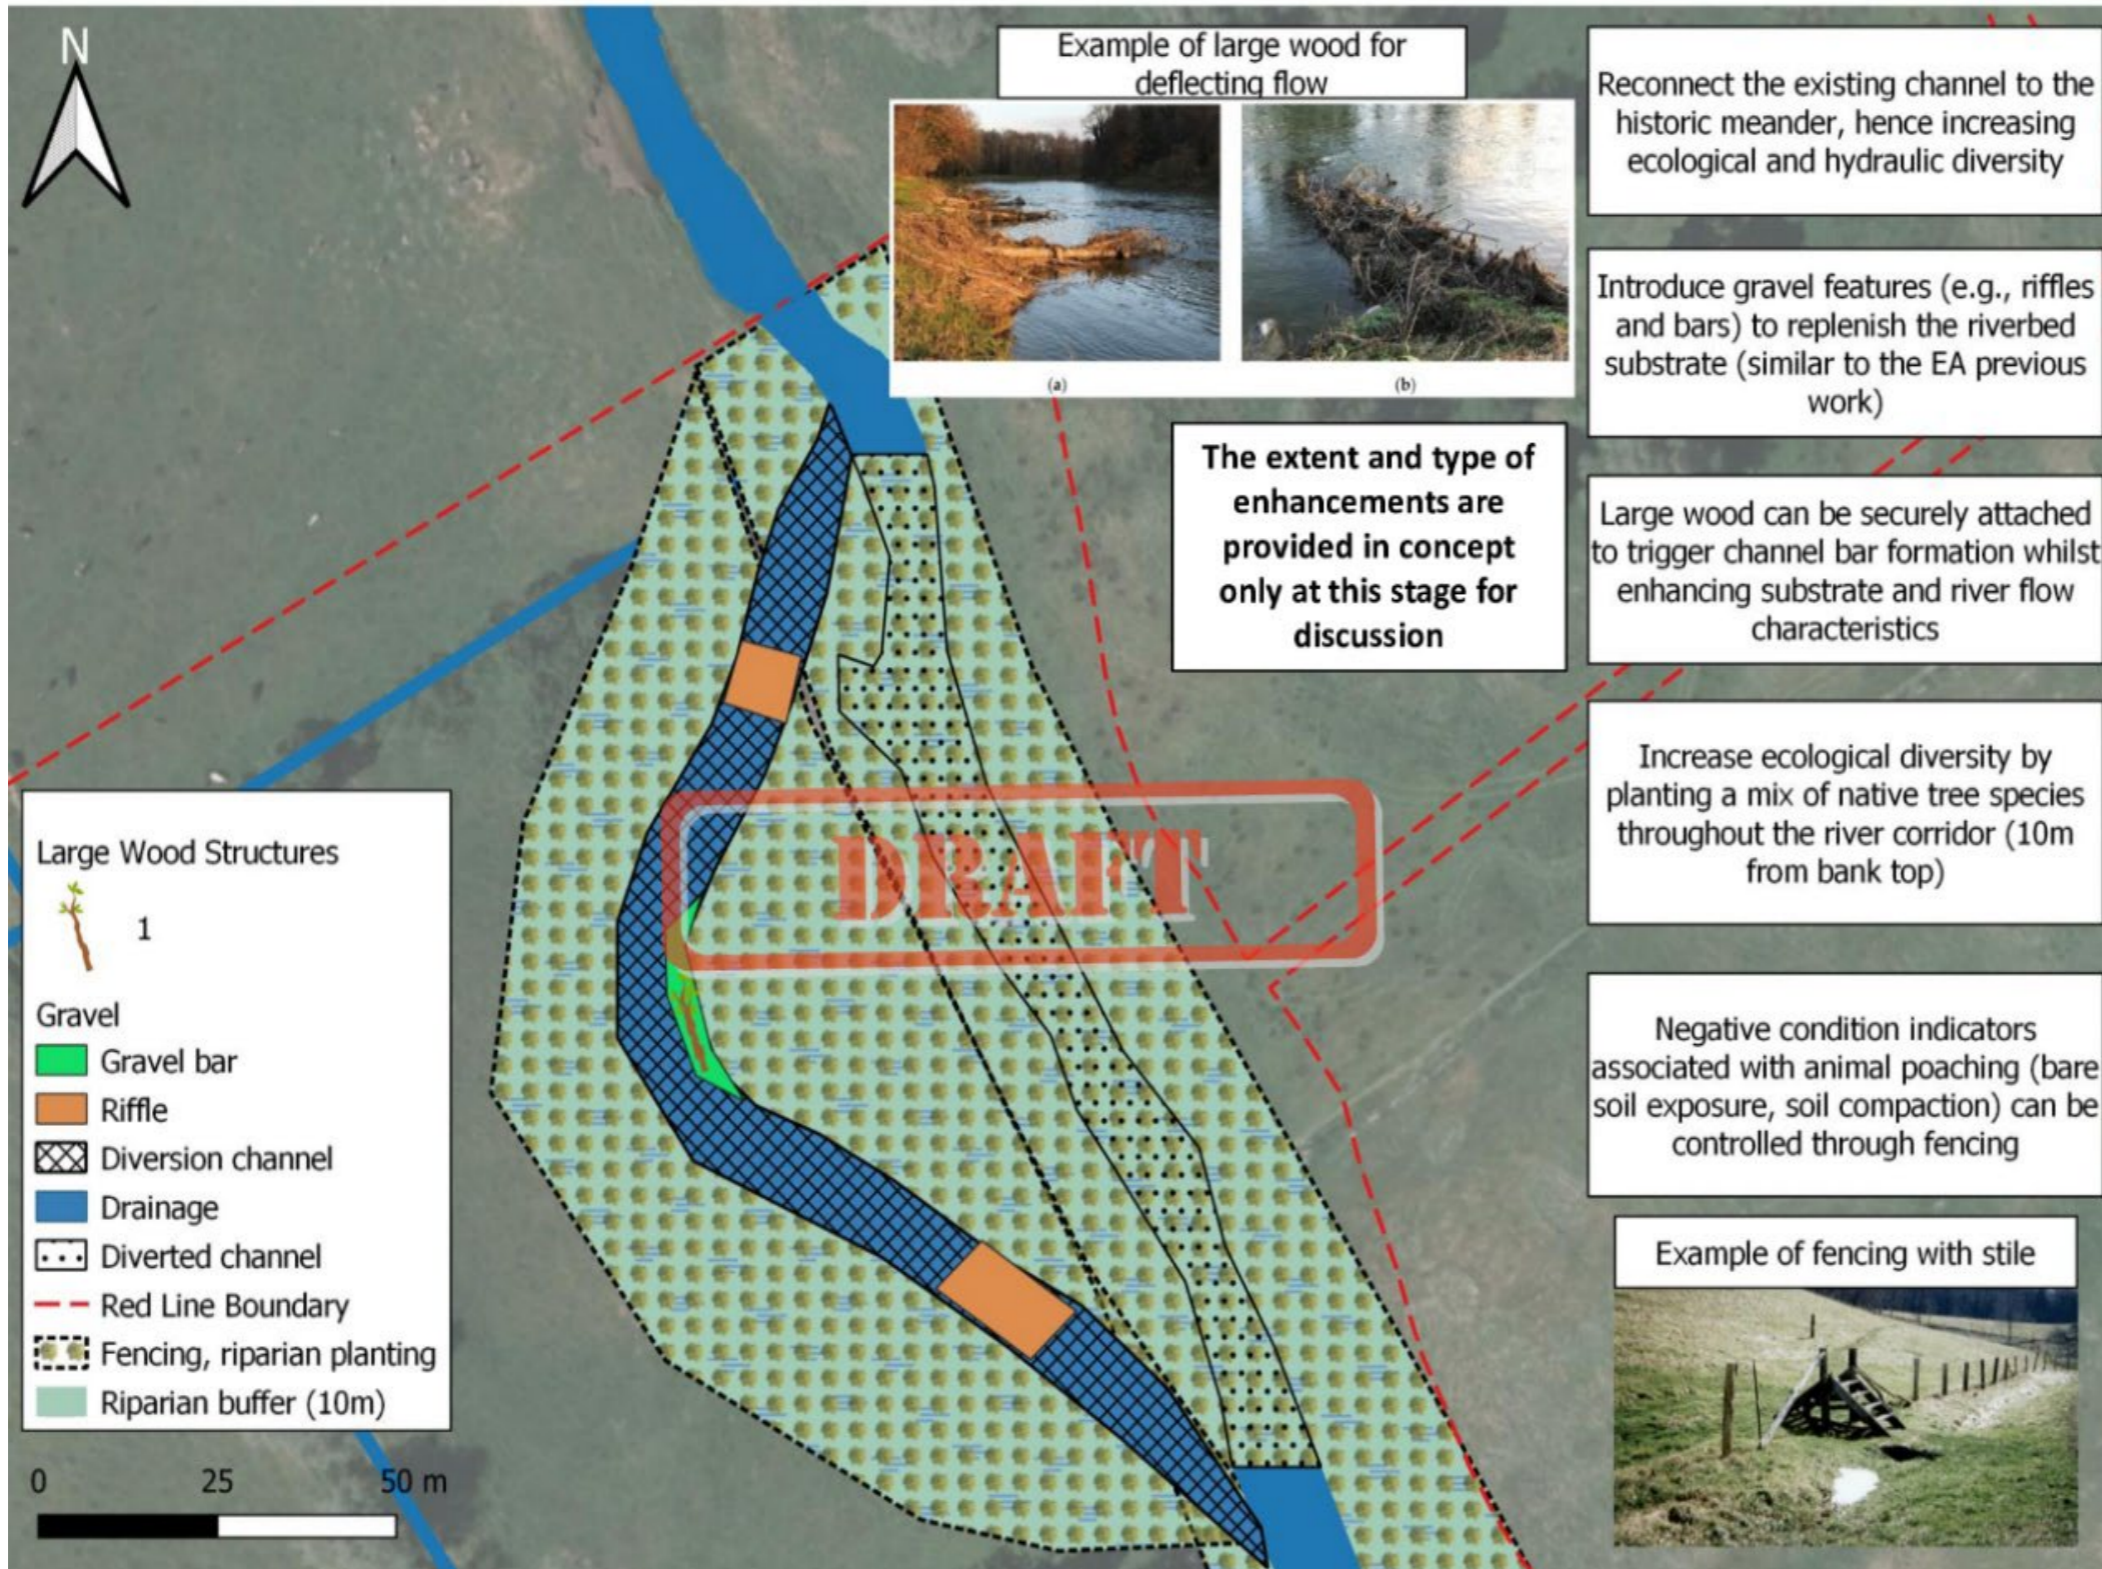
Figure D-2 Concept design of the proposed enhancements (subject to feasibility) for the River Wensum within panel A

Morton Estate – Wensum Area A

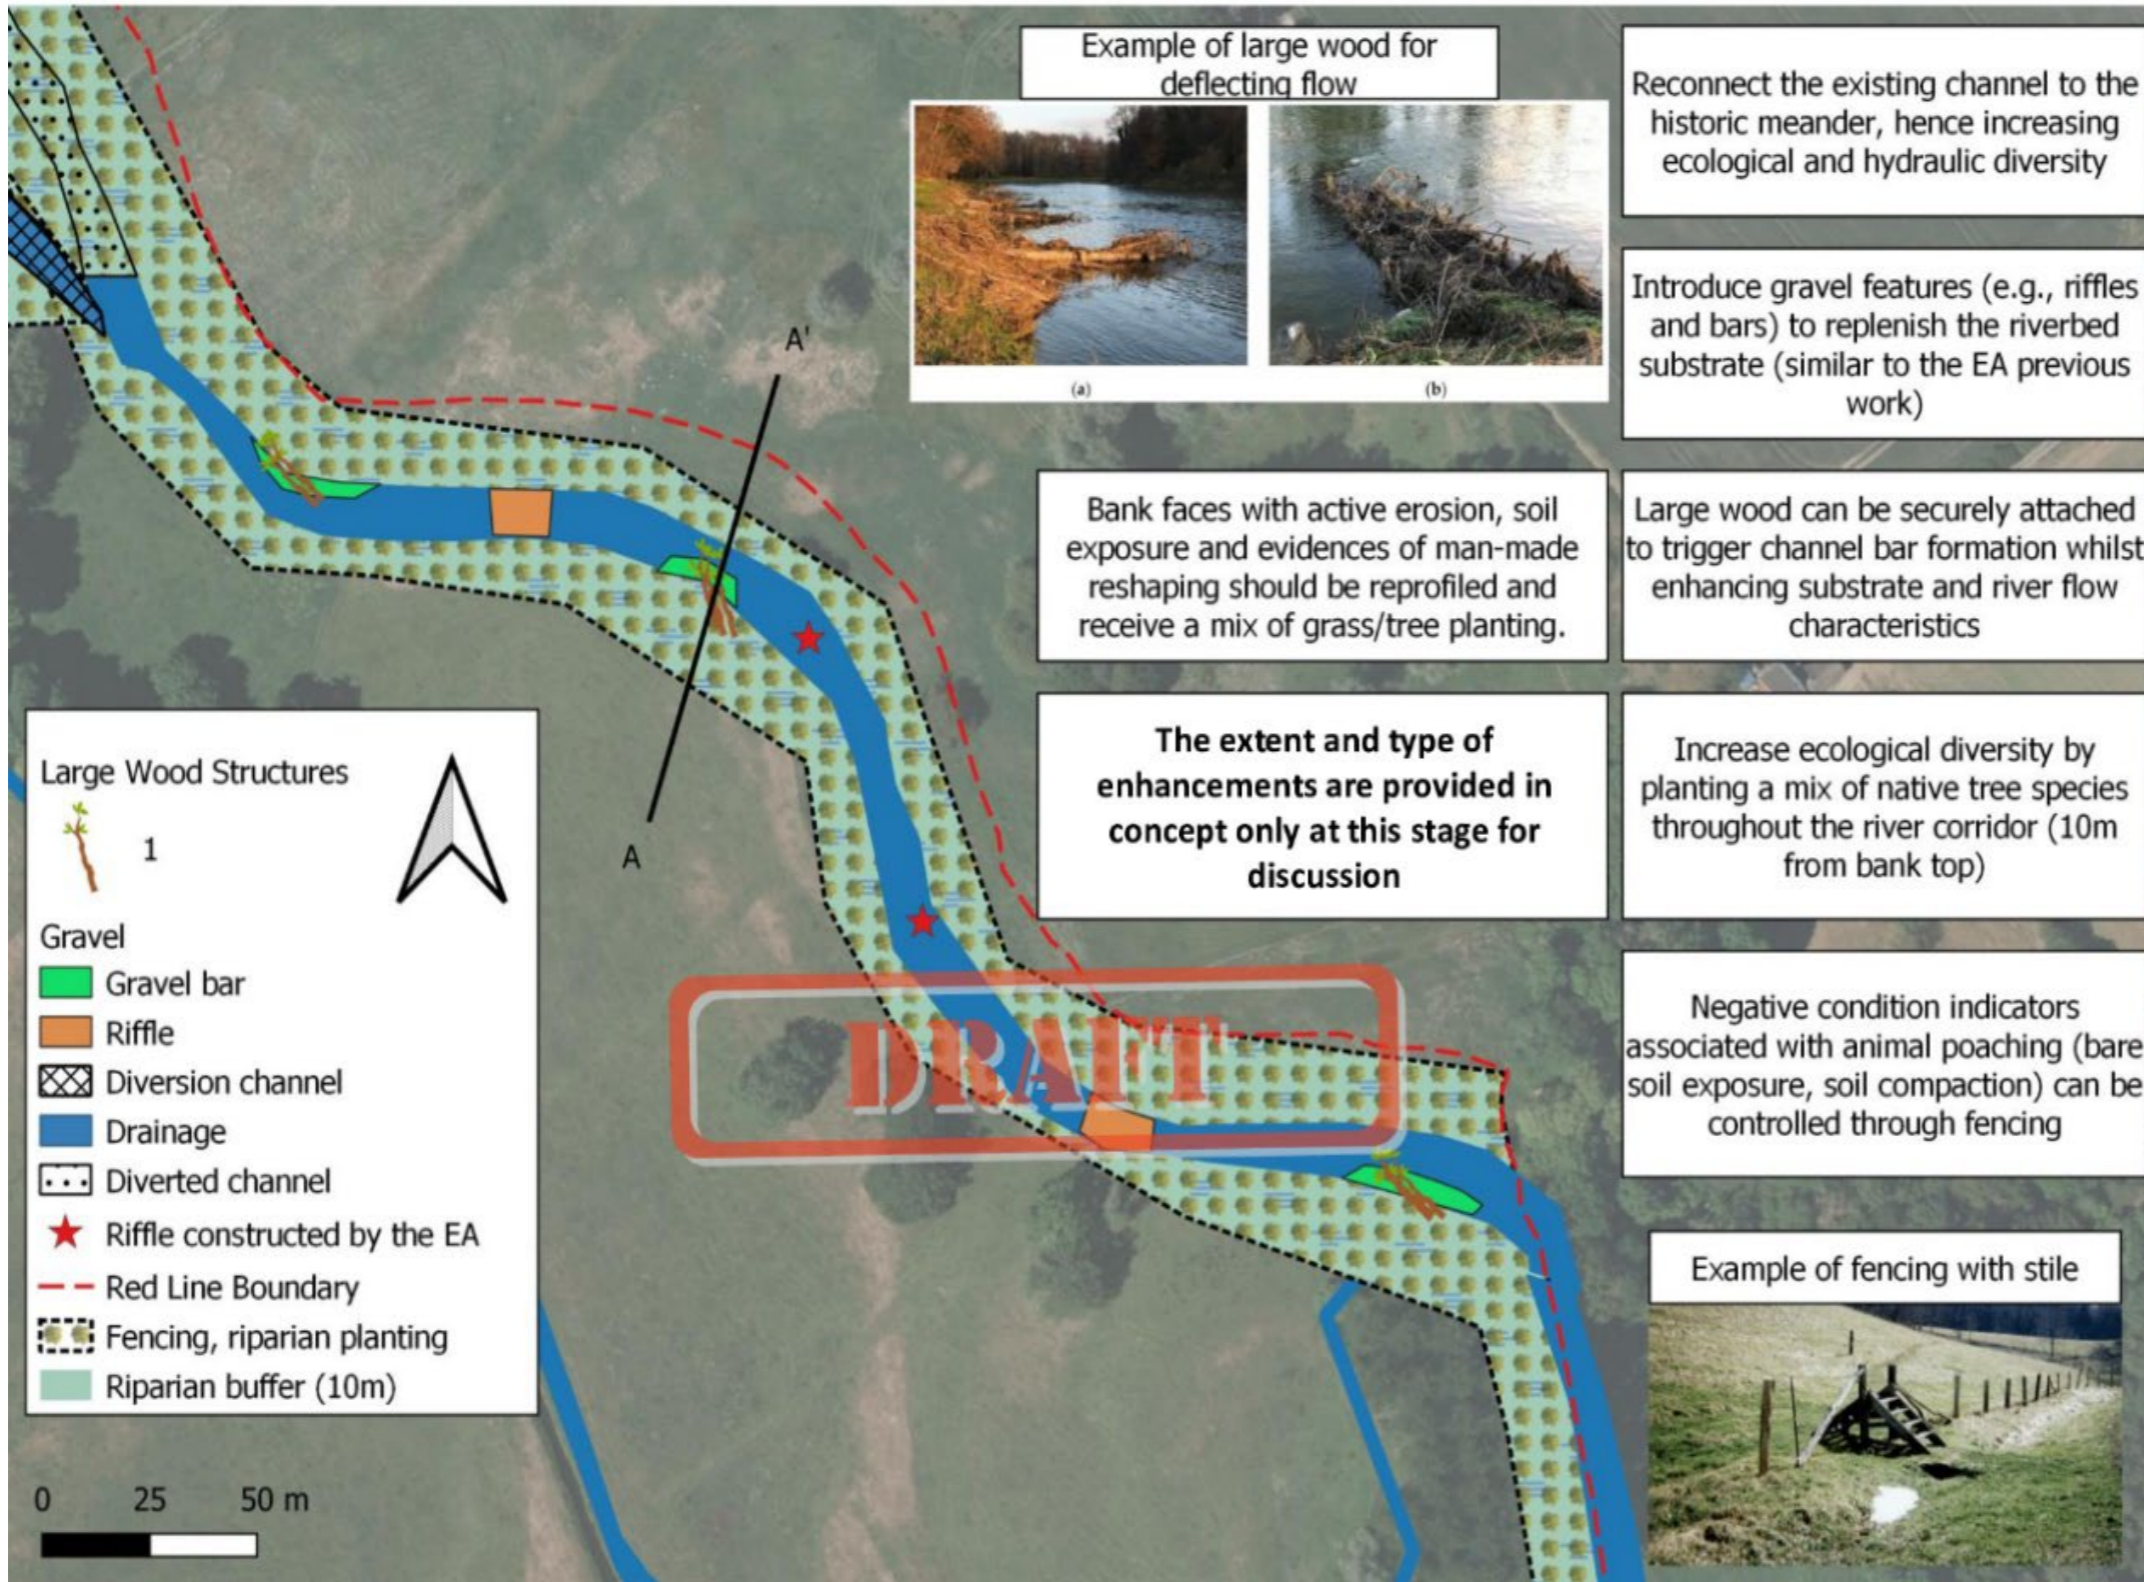
Figure D-3 Concept design of the proposed enhancements (subject to feasibility) for the River Wensum within panel B

Morton Estate – Wensum Area B

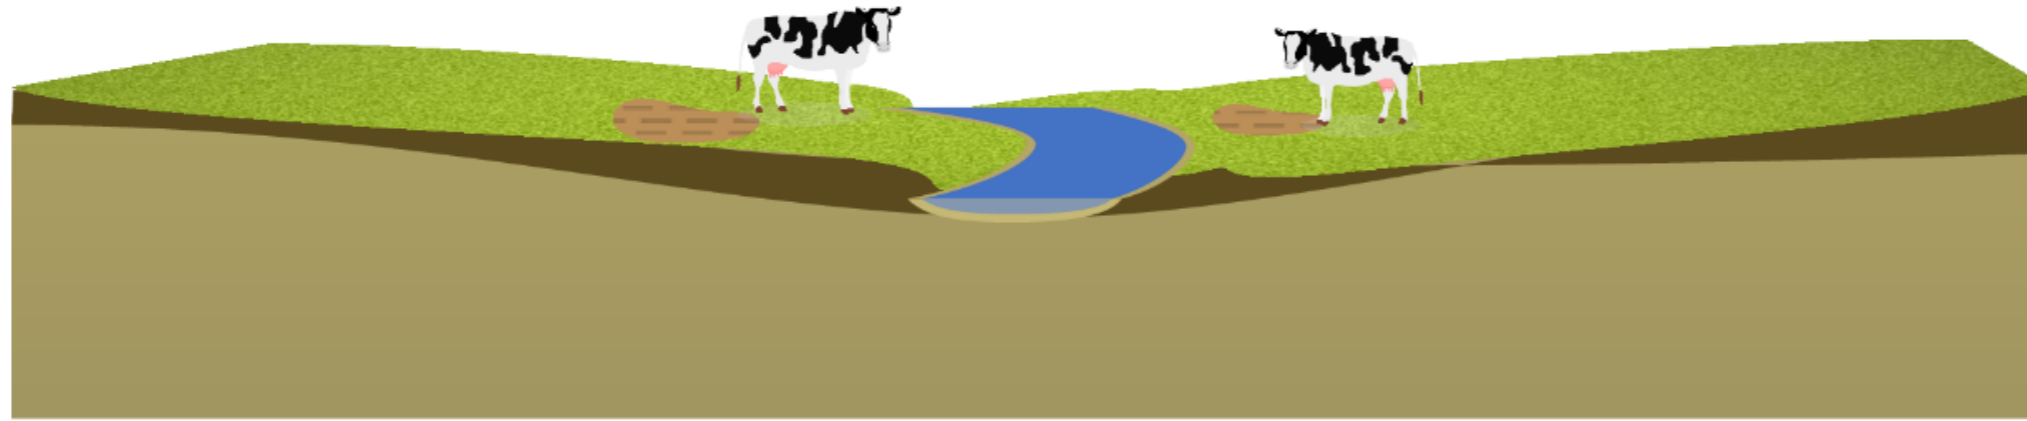
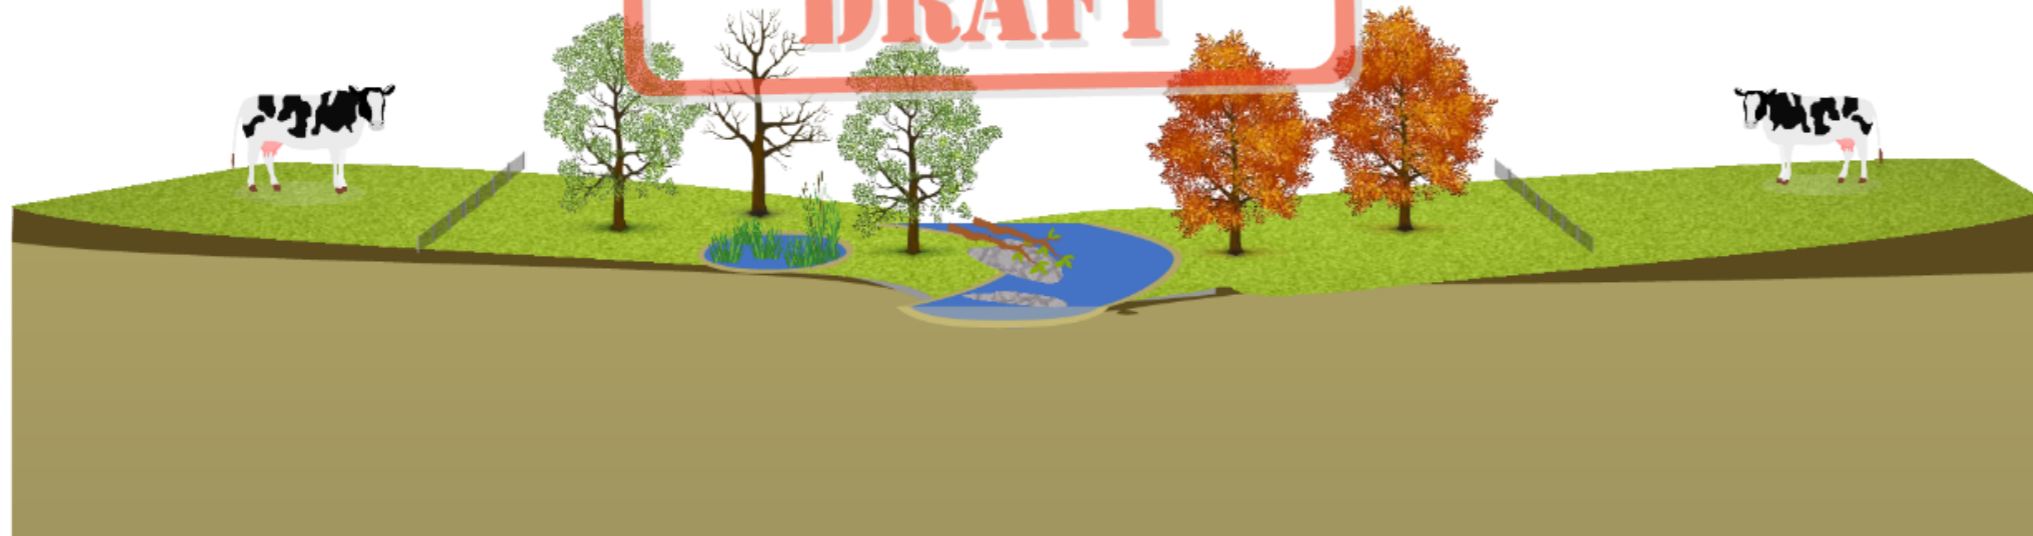
Figure D-4 Cross-section of the concept design of the proposed enhancements (subject to feasibility) for the River Wensum

A River Wensum – Baseline

River Wensum – Enhancement works

Wet woodland

Large wood structure with gravel bar

Riverbed gravel replenishment

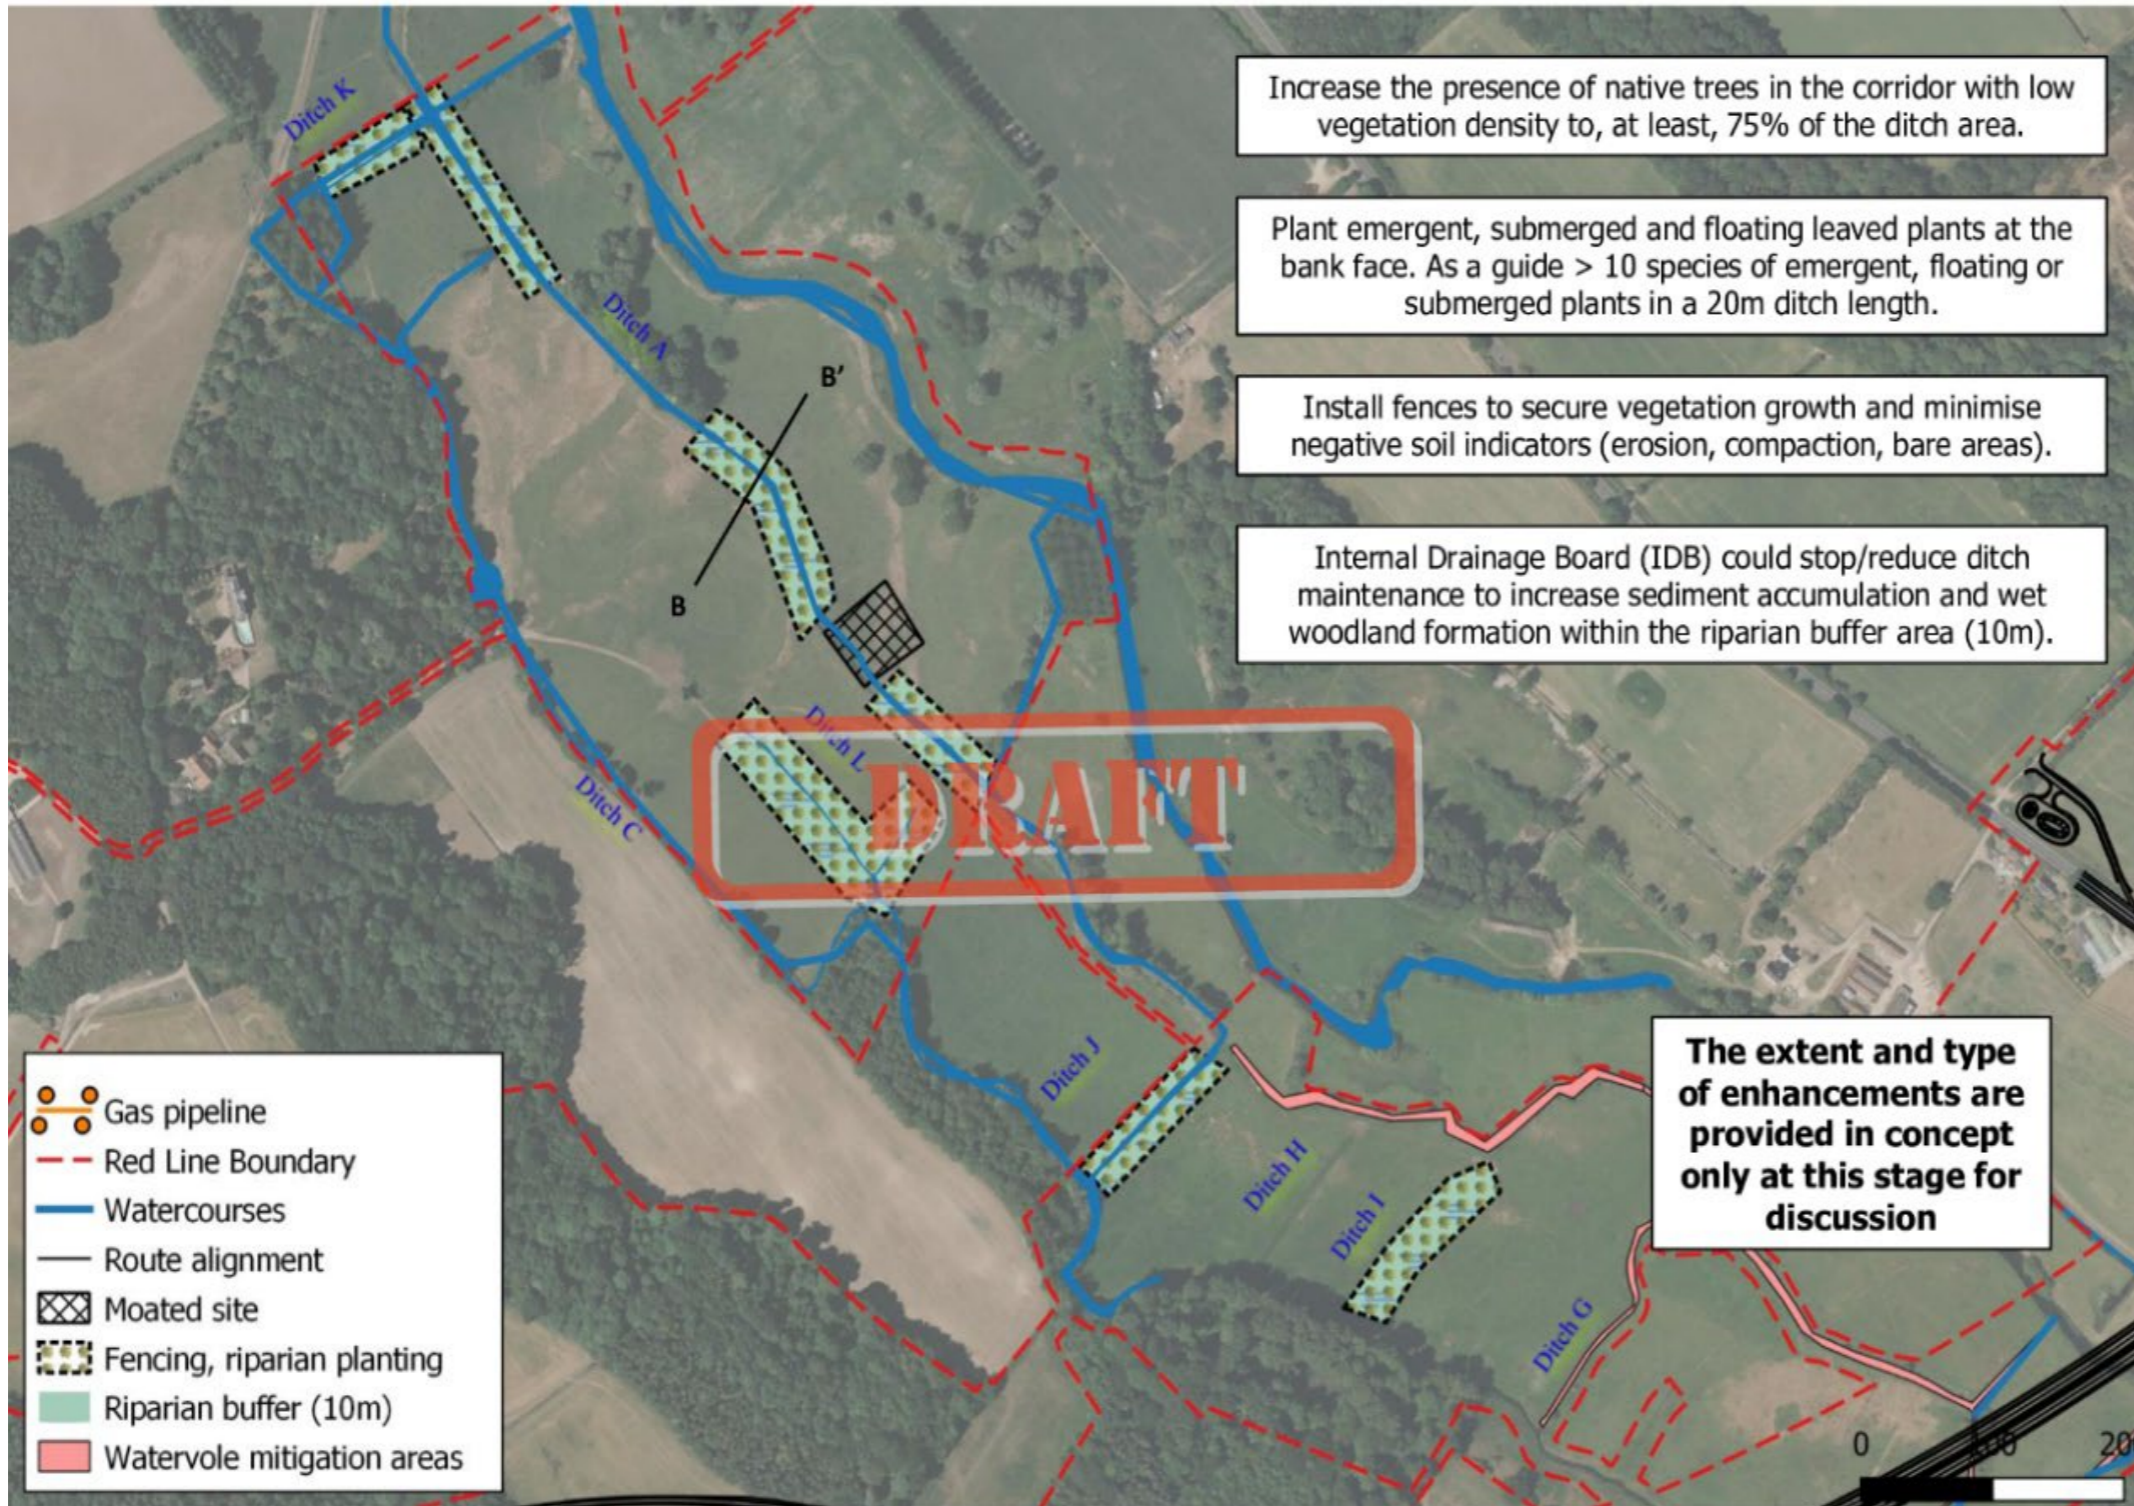
Figure D-5 Concept design of the proposed enhancements (subject to feasibility) for the ditches

Morton Estate – Ditches

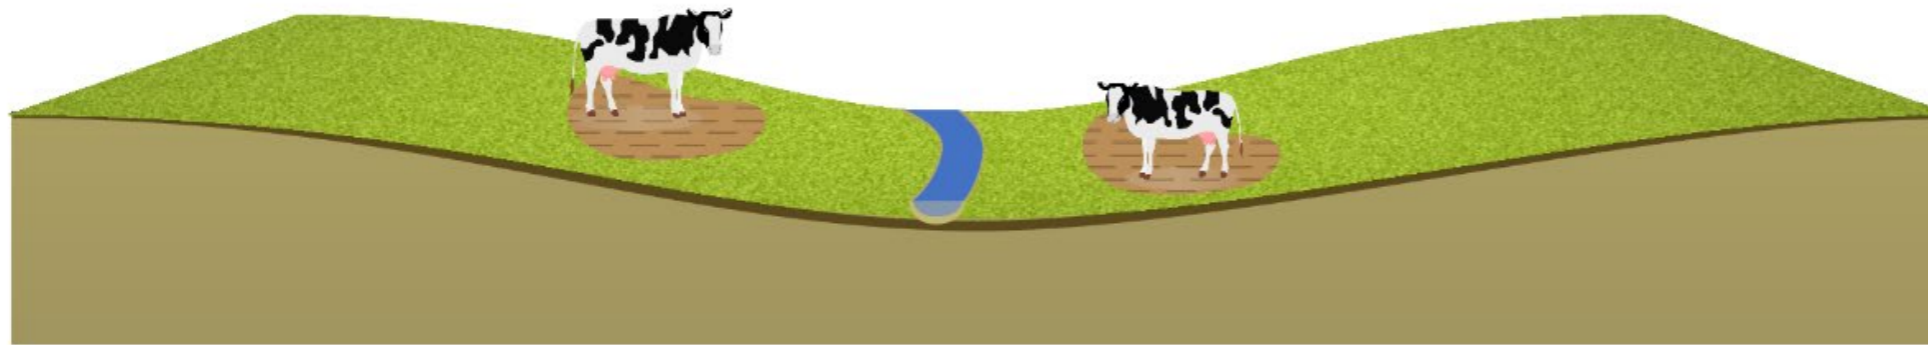
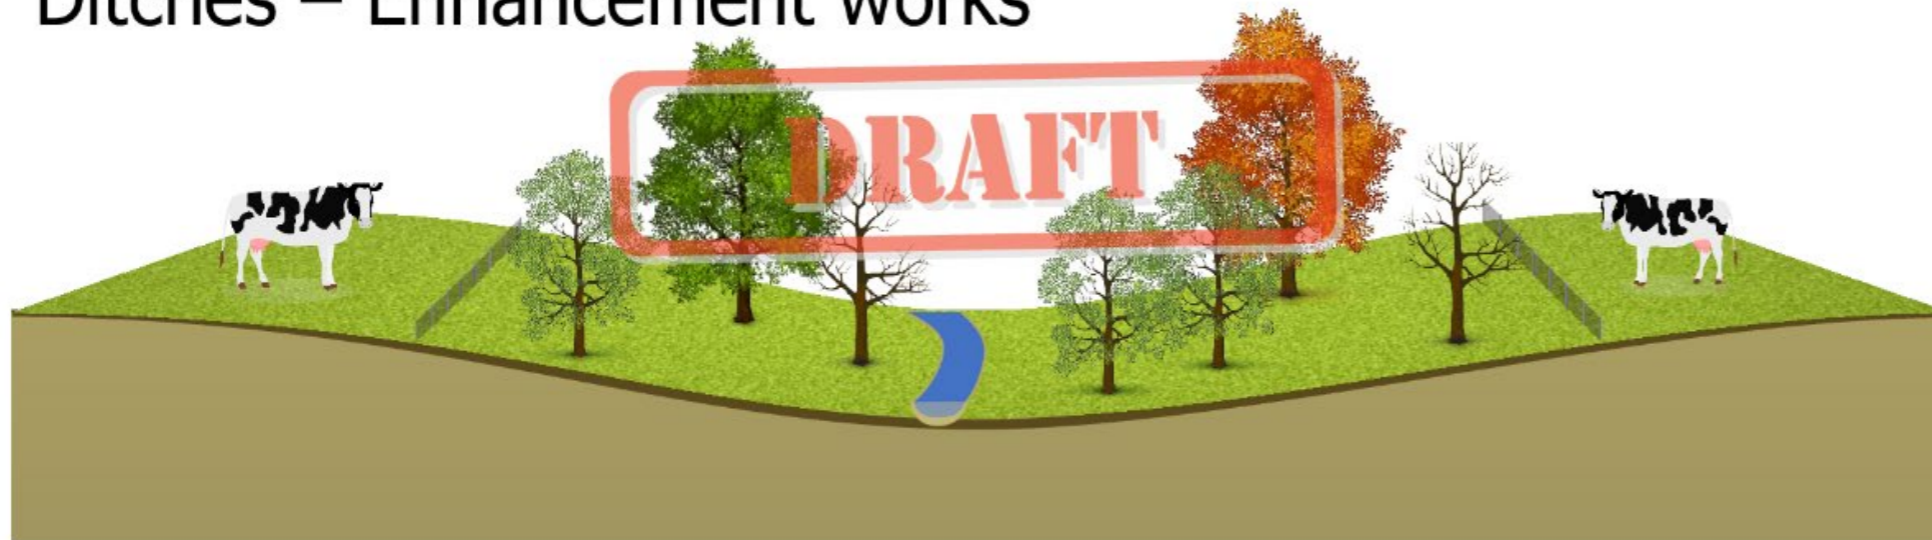
Figure D-6 Cross-section of the concept design of the proposed enhancements (subject to feasibility) for the ditches

Ditches – Baseline

Ditches – Enhancement works

Wet woodland

Deciduous trees

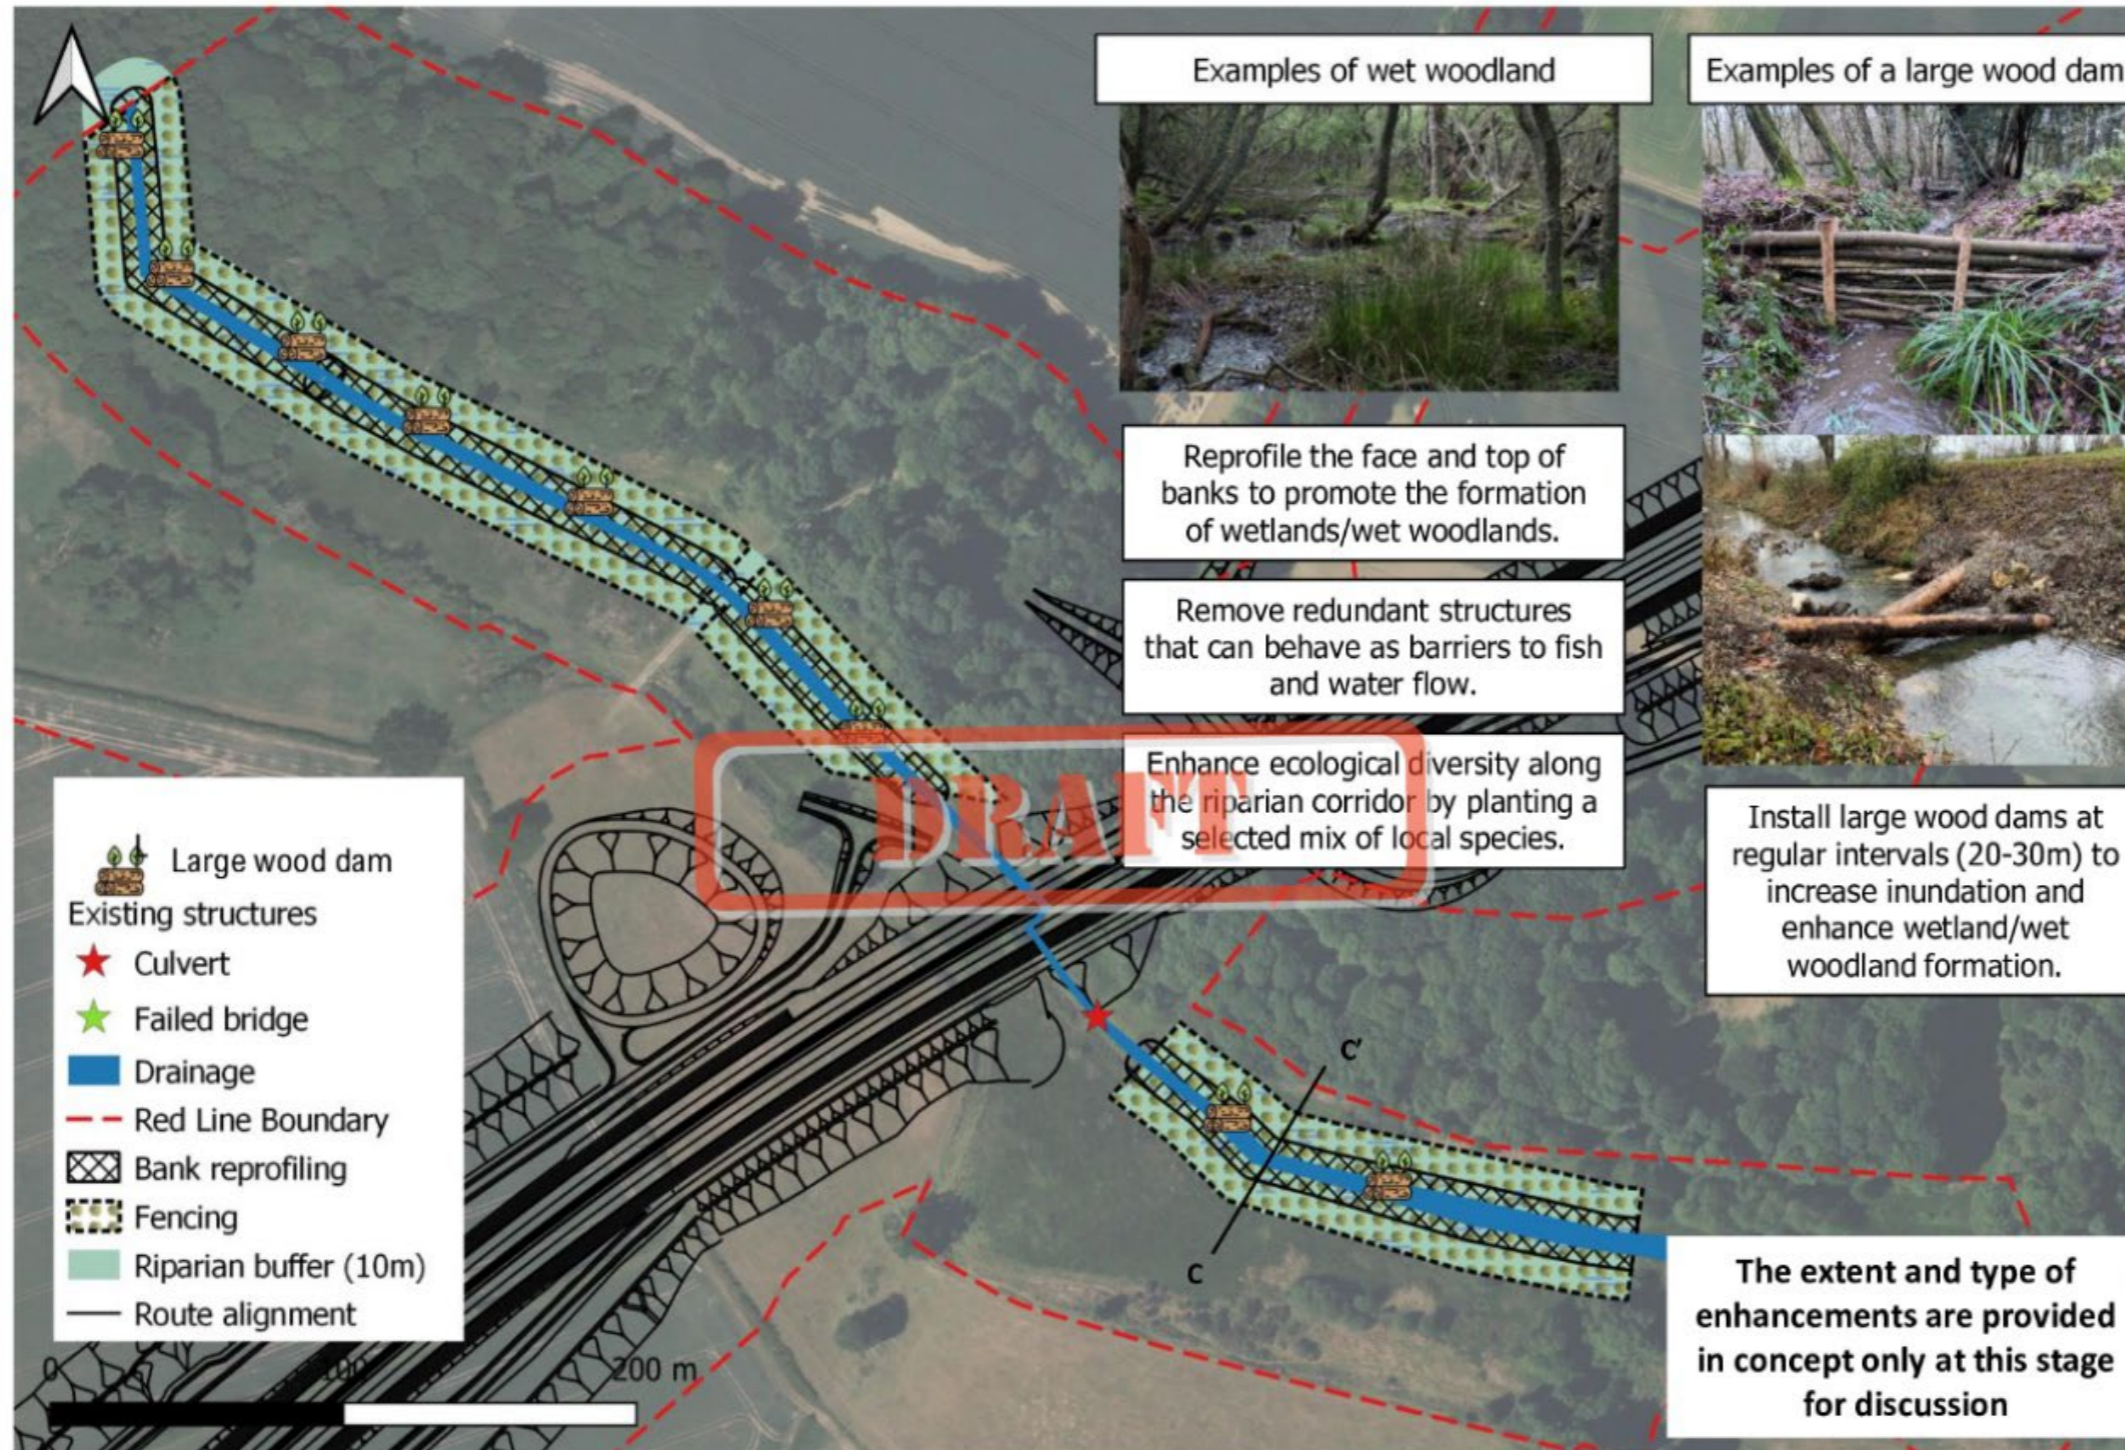
Figure D-7 Concept design of the proposed enhancements (subject to feasibility) for the Foxburrow Stream

Foxburrow Stream

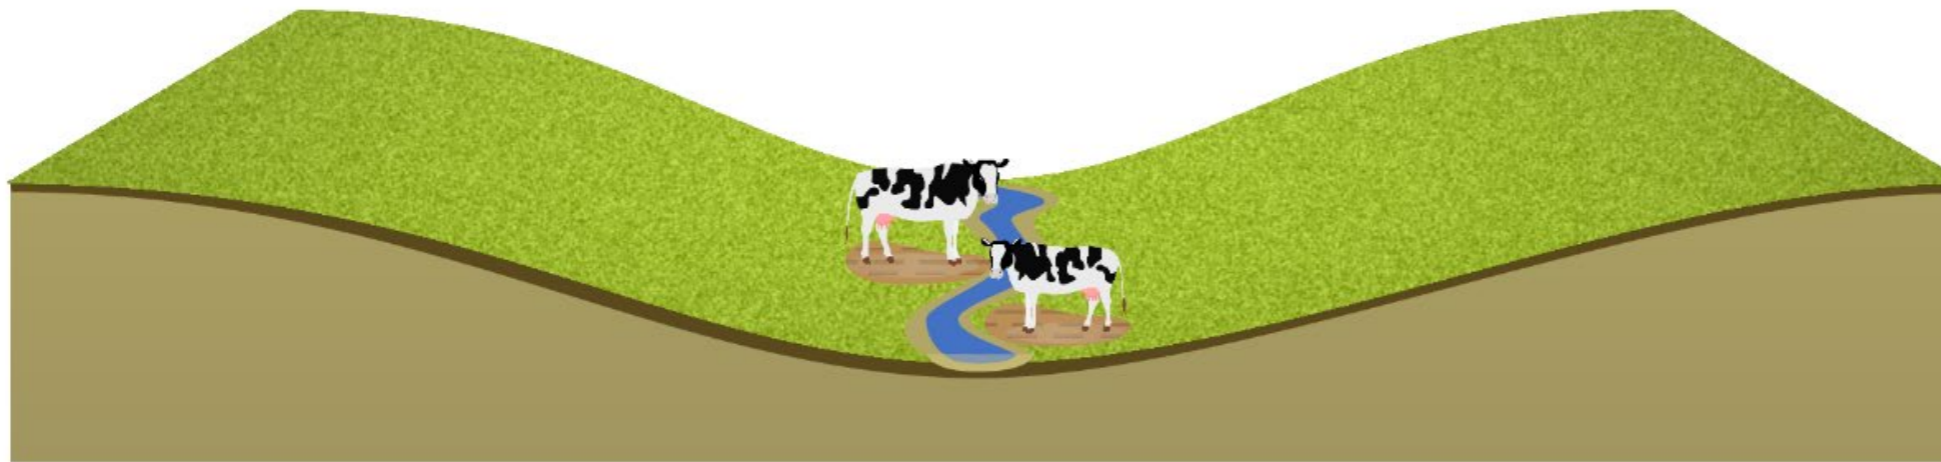
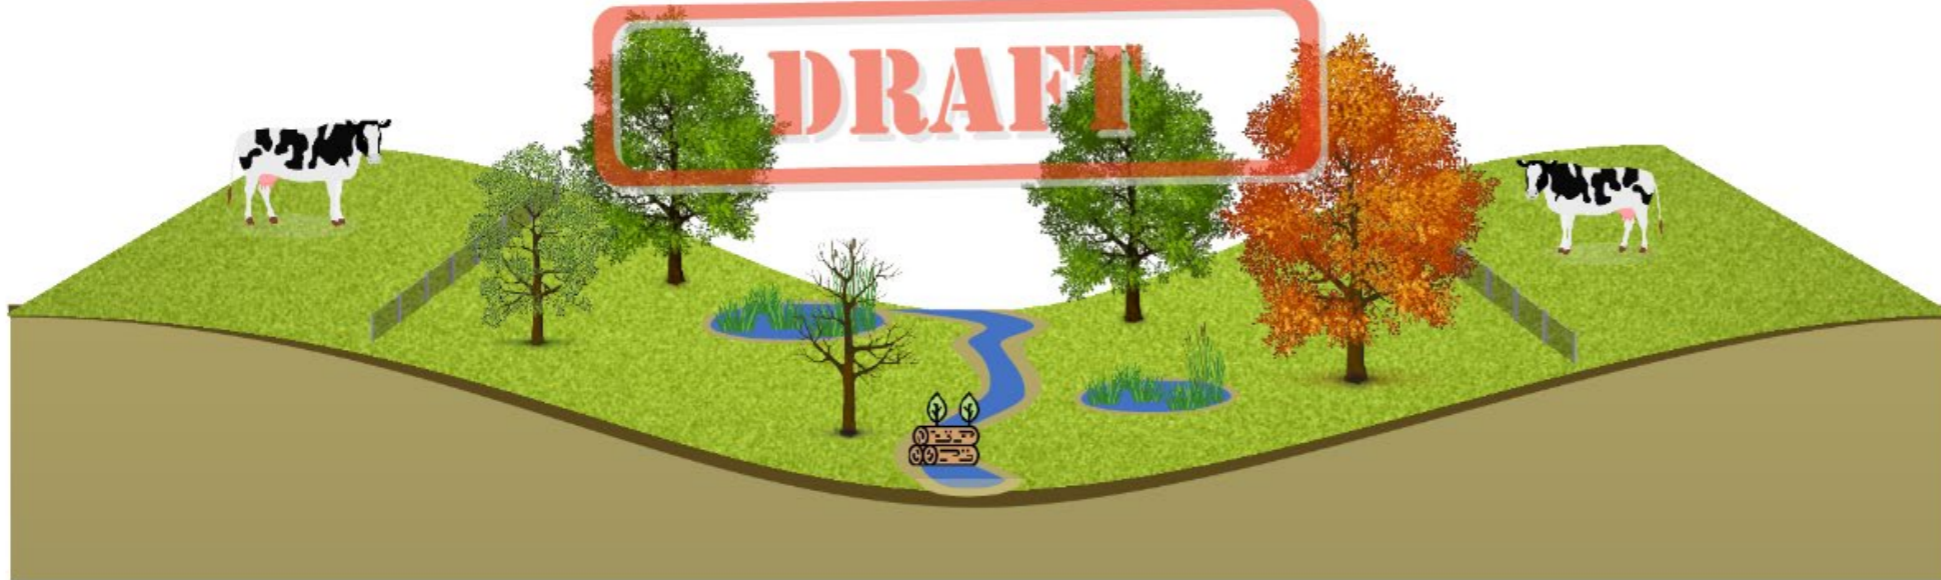
Figure D-8 Cross-section of the concept design of the proposed enhancements (subject to feasibility) for the Foxburrow Stream

C Foxburrow Stream – Baseline C'

Foxburrow Stream – Enhancement works

Wet woodland	Deciduous trees	Large wood dam
		 			Fence
		 			Surface soil
